Sonoma County Library Annex Building Study

FINAL REPORT | 19 APRIL 2023

FACILITY CONDITION ASSESSMENT

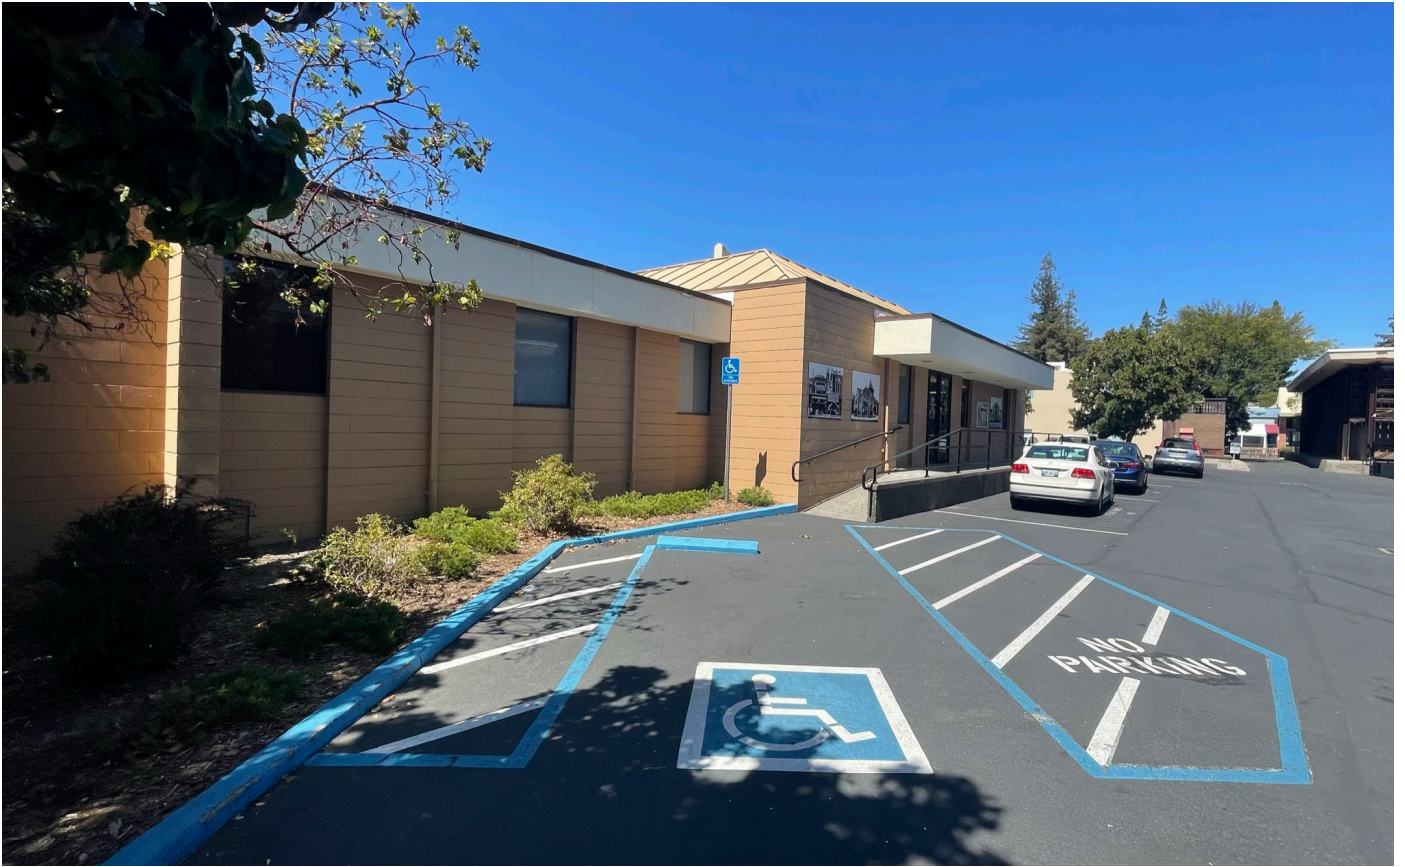
Above: In 2018, the Annex's staff and delivery entrance was converted into the new public entry with a ramp and parking. Site and building accessibility upgrades are recommended in the Bureau Veritas report (see Appendix C).

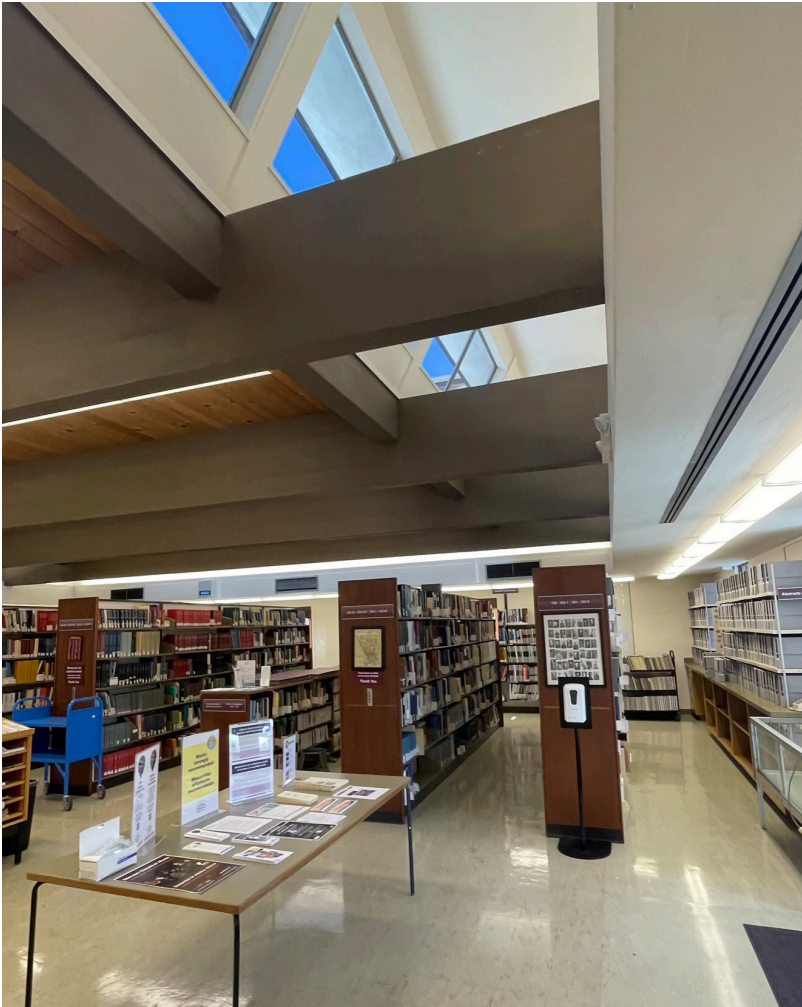
Left: Film has been applied to the clerestory windows to reduce — but unfortunately not eliminate — exposure of H&G's collection to ultraviolet light. The UV light that still comes in limits where sensitive materials can be displayed in the main research space.

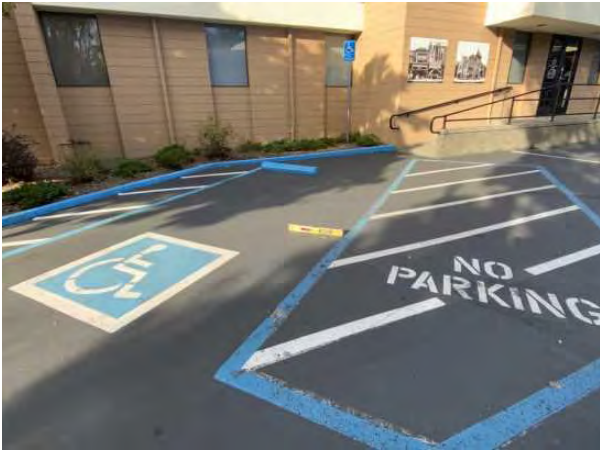
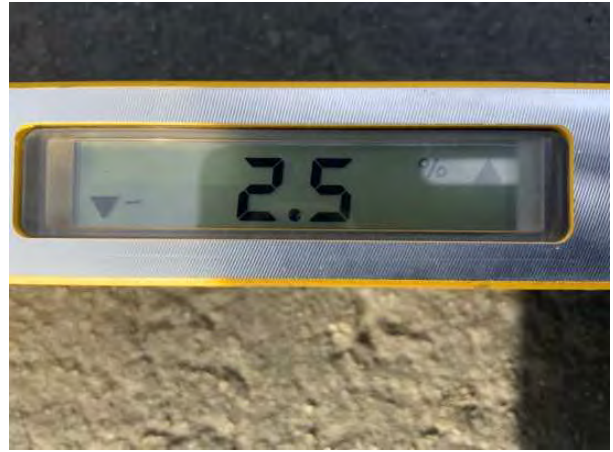
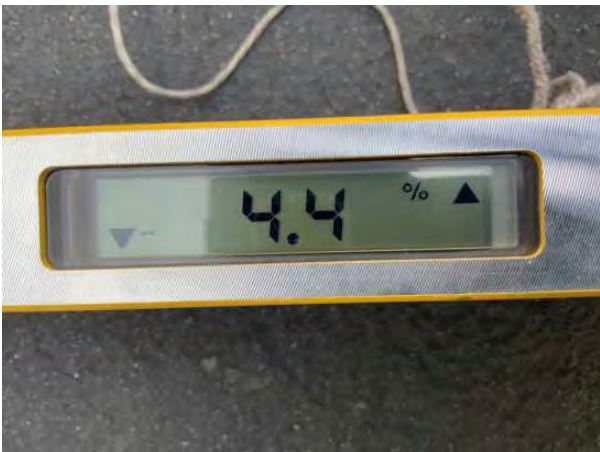
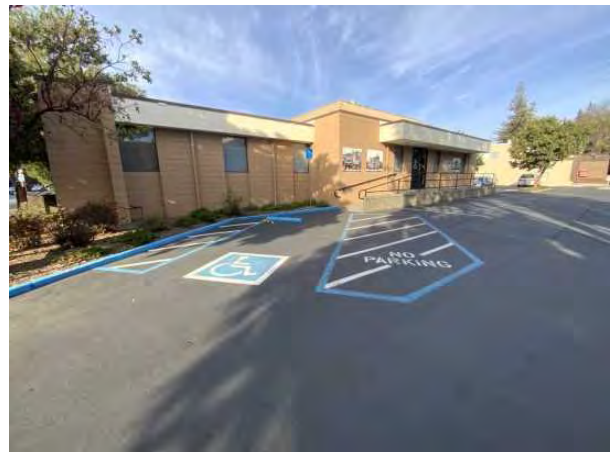
Photos for Barrier ID: AX298639

Assembly	Entrance to Building
Type	Building Entrance - Door
ADA Standard	CBC Chap 11B-404.2
Barrier Detail	CALIFORNIA: The maneuvering clearance at the entry door is not compliant.
Location Description	Main Entrance
Observed	Oct 16, 2022 by Justin.vang@bureauveritas.com

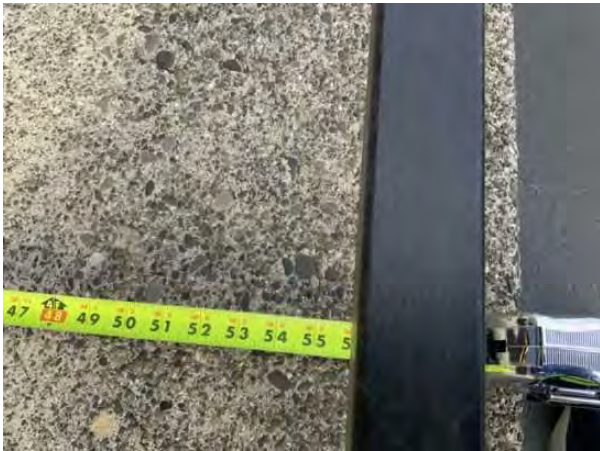
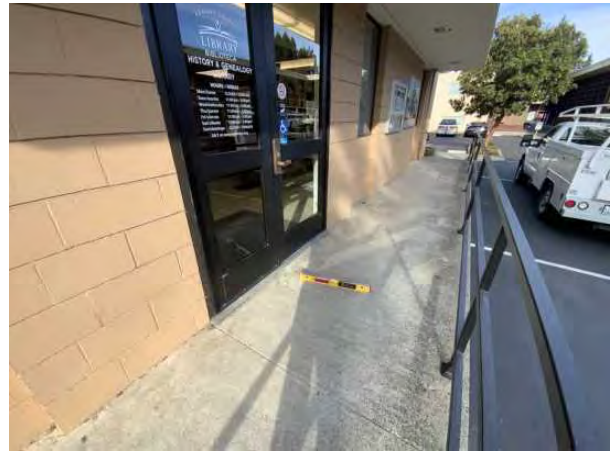
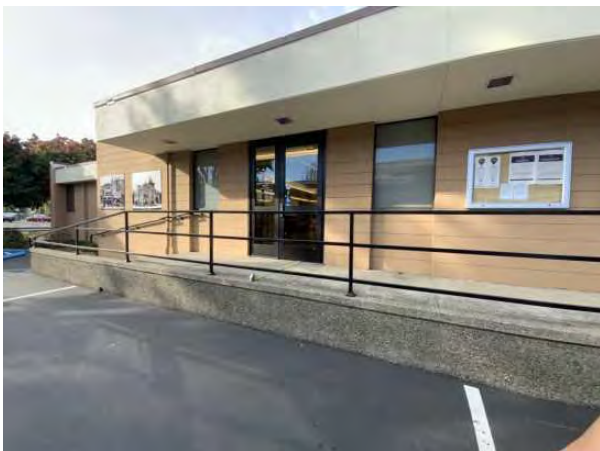
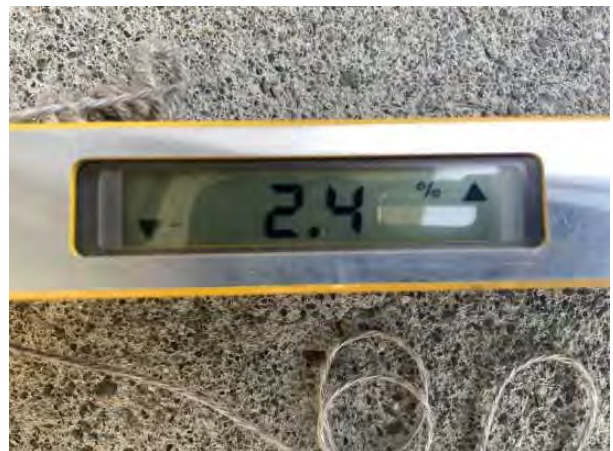
Photos for Barrier ID: AX298654

Assembly	Entrance to Building
Type	Door
ADA Standard	CBC Chap 11B- 404.2.9, 703.7
Barrier Detail	CALIFORNIA: The power operated door is not compliant.
Location Description	Main Entrance
Observed	Oct 16, 2022 by Justin.vang@bureauveritas.com
Site Conditions	The power assist does not have the proper sign.

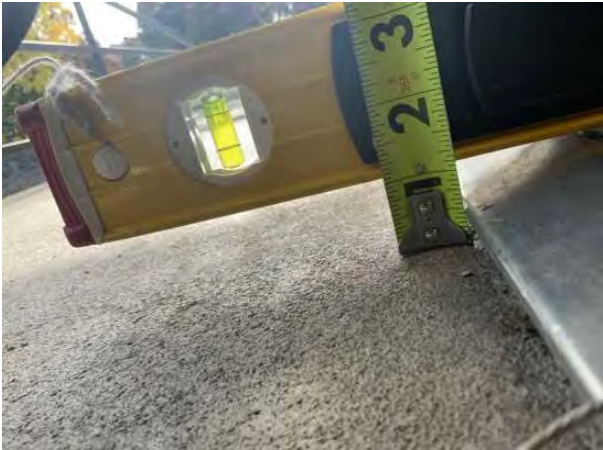
Assembly	Interior Access Route
Type	Building Entrance-Floor Surface
ADA Standard	302.2
Barrier Detail	The edges of the carpet are not securely attached.
Location Description	Main Entrance
Observed	Oct 16, 2022 by Justin.vang@bureauveritas.com
Site Conditions	The carpet edges are not attached.

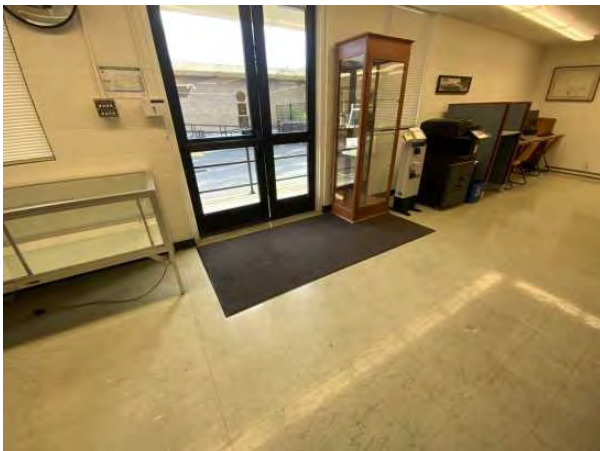
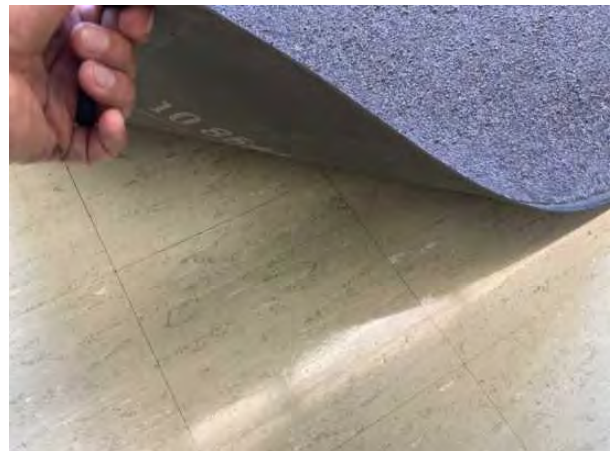
Photos for Barrier ID: AX298659

Assembly	Interior Access Route
Type	Door
ADA Standard	302.3
Barrier Detail	The floor surface has openings in the surface greater than 1/2".
Location Description	Main Entrance
Observed	Oct 16, 2022 by Justin.vang@bureauveritas.com
Site Conditions	The threshold has a 1-1/2" opening.

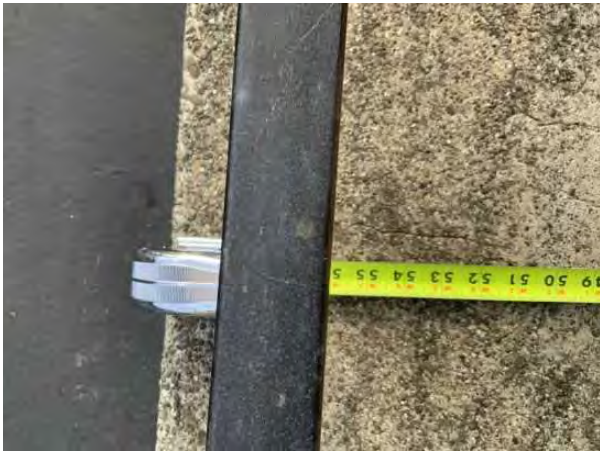
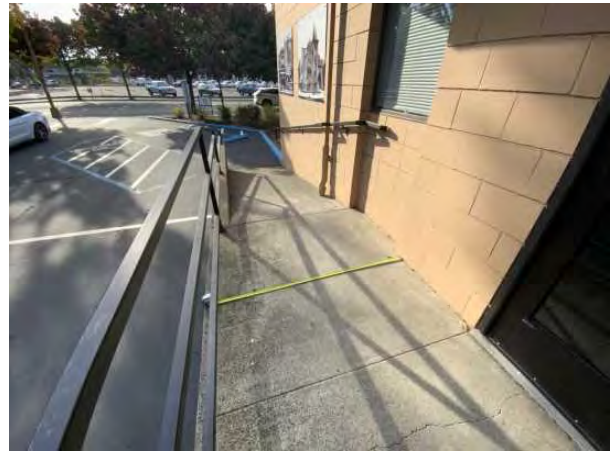
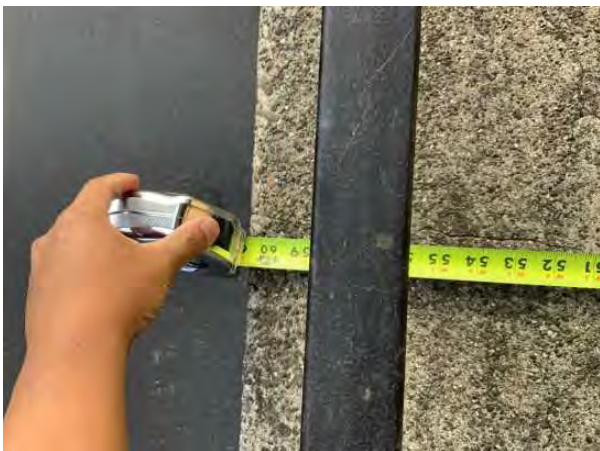
Photos for Barrier ID: AX298645

Assembly	Exterior Access Route
Type	Ramp
ADA Standard	California Building Code Chap 11B-Chap 11B-405.7
Barrier Detail	CALIFORNIA: The ramp landings are not compliant.
Location Description	Ramp R1
Observed	Oct 16, 2022 by Justin.vang@bureauveritas.com
Site Conditions	The bottom landing slope is 3.6%.
Highest Cross Slope	3.6%

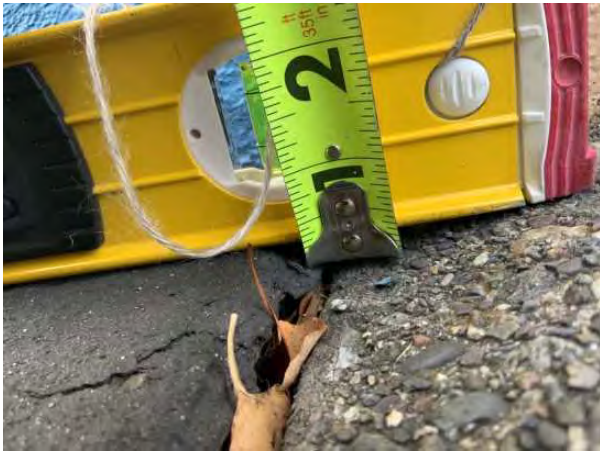
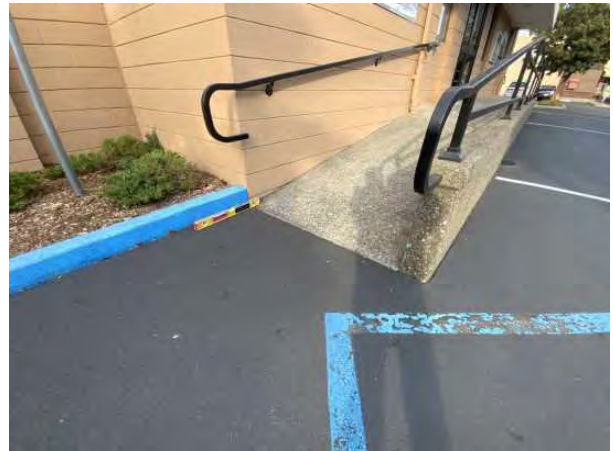
Photos for Barrier ID: AX298642

Assembly	Exterior Access Route
Type	Ramp
ADA Standard	California Building Code Chap 11B-405
Barrier Detail	CALIFORNIA: The ramp has running slopes and/or rises in excess of 1:12.
Location Description	Ramp R1
Observed	Oct 16, 2022 by Justin.vang@bureauveritas.com
Site Conditions	The running slope is 15.8% - 16.8% for a length of 10'.
Highest Running Slope	16.8%
Lowest Running Slope	15.8%

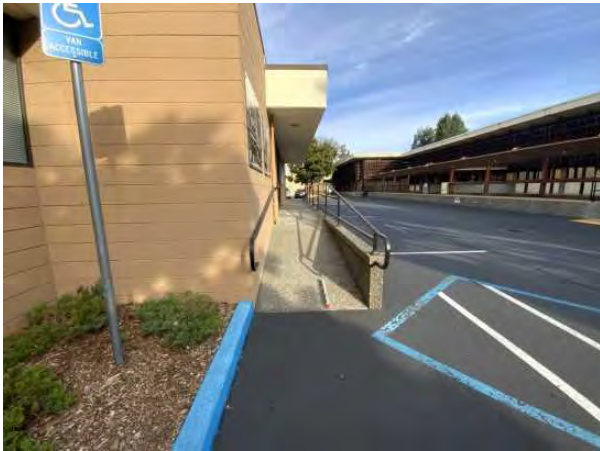
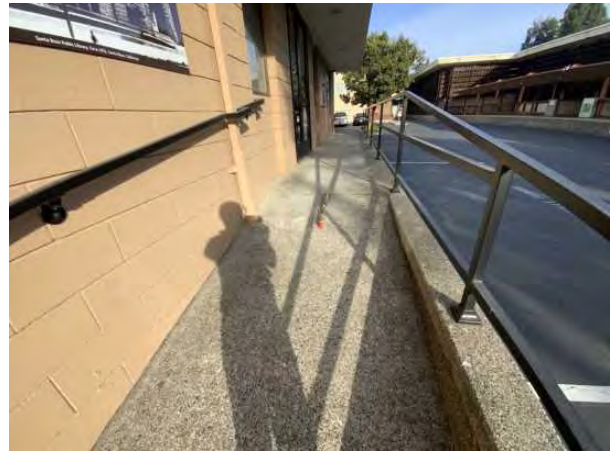
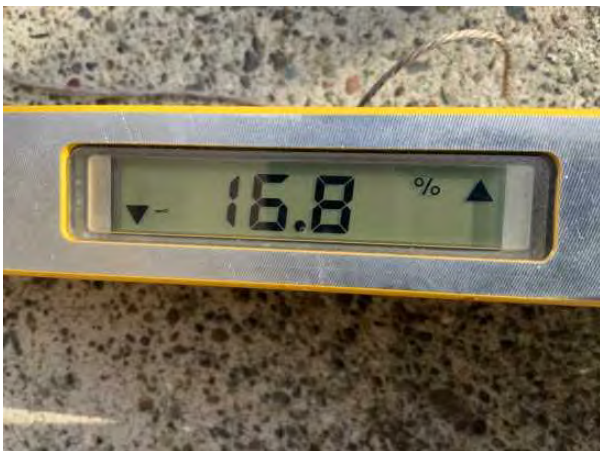
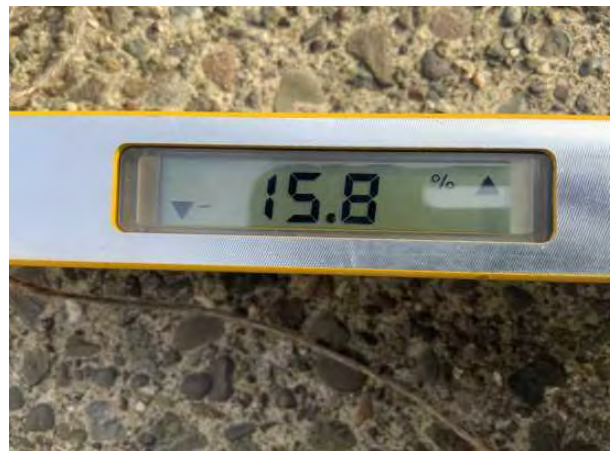
Photos for Barrier ID: AX298643

Assembly	Exterior Access Route	
Type	Ramp	
ADA Standard	California Building Code Chap 11B-405.9.2	
Barrier Detail		
CALIFORNIA: The ramp run does not have edge protection or the edge protection is not compliant.		
Location Description	Ramp R1	
Observed	Oct 16, 2022 by Justin.vang@bureauveritas.com	
Site Conditions	The pipe obstructs the edge protection.	
Resolution		
Provide edge protection on the sides of the ramp runs. Compliant edge protection shall be provided on each side of ramp runs and at each side of ramp landings. A curb, 2 inches high minimum, or barrier shall be provided that prevents the passage of a 4" diameter sphere, where any portion of the sphere is within 4" of the finish floor or ground surface. To prevent wheel entrapment, the curb or barrier shall provide a continuous and uninterrupted barrier along the length of the ramp. [EXCEPTIONS: 1.Edge protection shall not be required on ramps that are not required to have handrails and have sides. 2.Edge protection shall not be required on the sides of ramp landings serving an adjoining ramp run or stairway. 3. Edge protection shall not be required on the sides of ramp landings having a vertical drop-off of 1/2" maximum within 10" horizontally of the minimum landing area.]

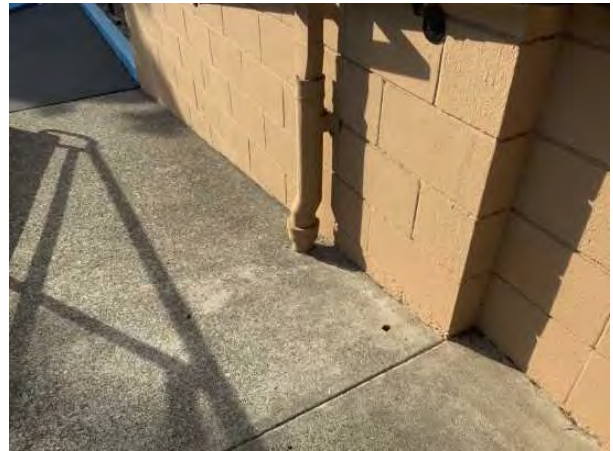
Photos for Barrier ID: AX298644

Assembly	Exterior Access Route
Type	Ramp
ADA Standard	California Building Code Chap 11B-Chap 11B-405.3
Barrier Detail	CALIFORNIA: The exterior ramp is less than 48" wide.
Location Description	Ramp R1
Observed	Oct 16, 2022 by Justin.vang@bureauveritas.com
Site Conditions	The pipe reduces the ramp clear width to 47-1/2".

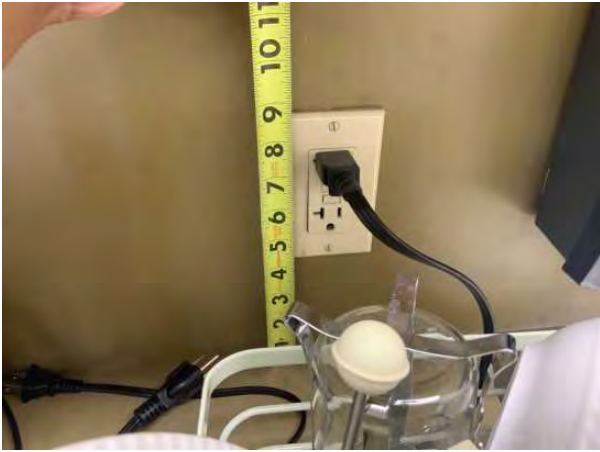
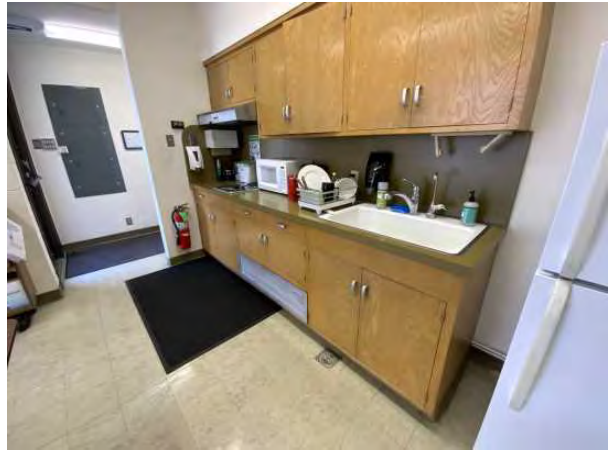
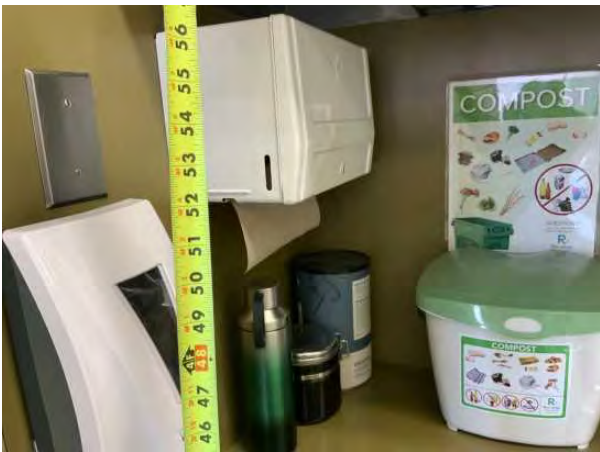
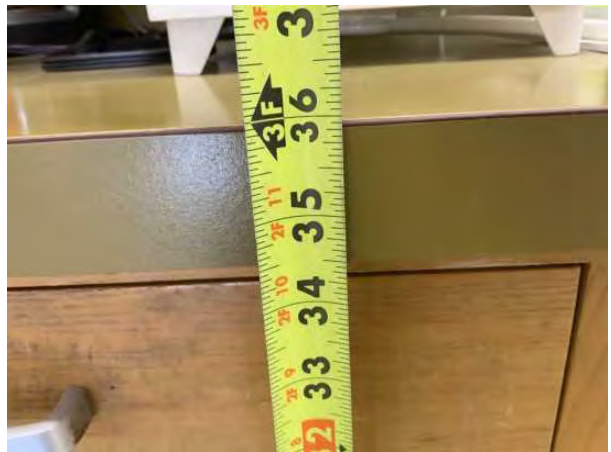
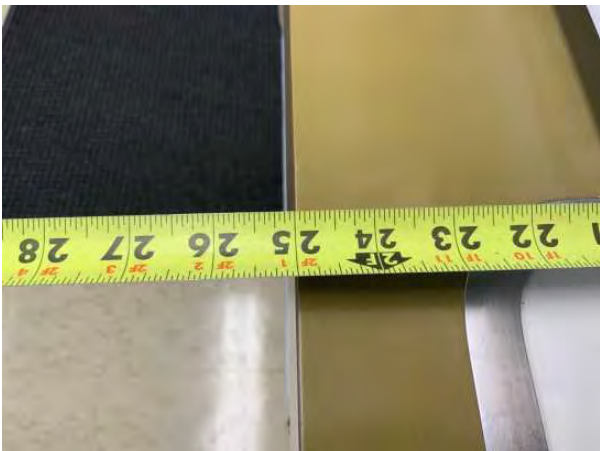
Assembly	Interior Access Route
Type	Dining And Work Surface
ADA Standard	CBC Chap 11B-306, 902
Barrier Detail	CALIFORNIA: The dining or work surface is not compliant.
Location Description	Catalog Computers
Observed	Oct 16, 2022 by Justin.vang@bureauveritas.com

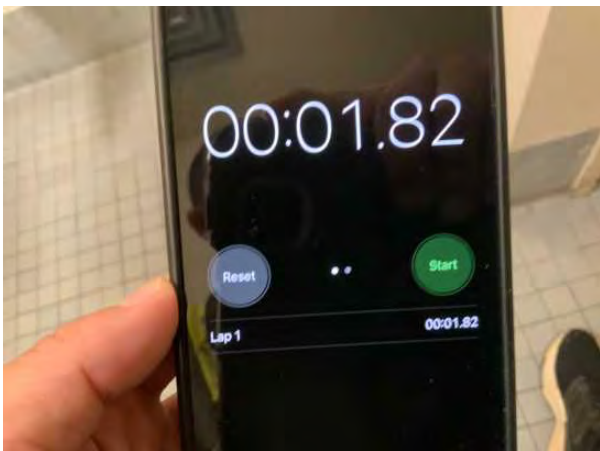
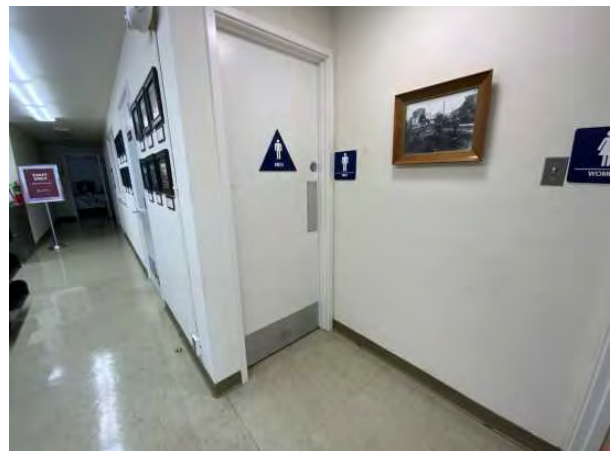
Photos for Barrier ID: AX298688

Assembly	Restroom
Type	Restroom/Bathroom - Door
ADA Standard	404.2.3
Barrier Detail	The door has less than 32" clear width.
Location Description	Men's Restroom
Observed	Oct 16, 2022 by Justin.vang@bureauveritas.com
Site Conditions	The door width is 27".

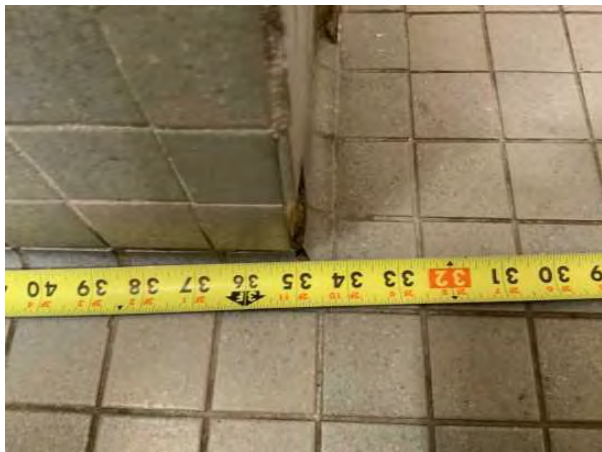
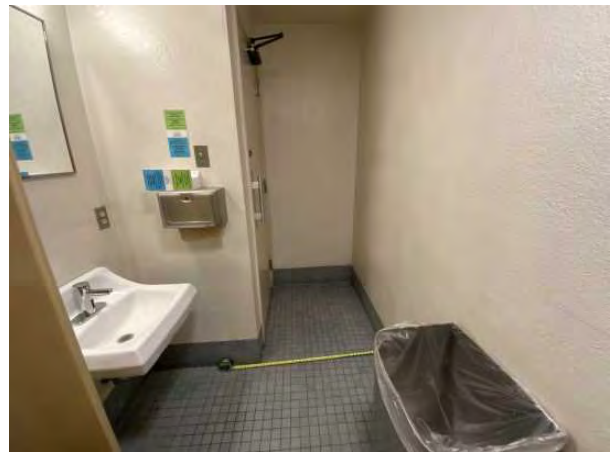
Photos for Barrier ID: AX298690

Assembly	Restroom
Type	Restroom/Bathroom - Floor Space
ADA Standard	304, 603.2.1; 603.2.2
Barrier Detail	The required turning space within the restroom is not provided.
Location Description	Men's Restroom
Observed	Oct 16, 2022 by Justin.vang@bureauveritas.com
Site Conditions	The turning space is 32-1/2" wide.

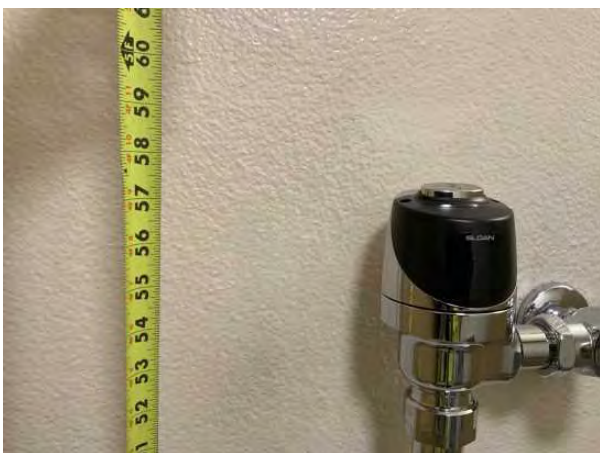
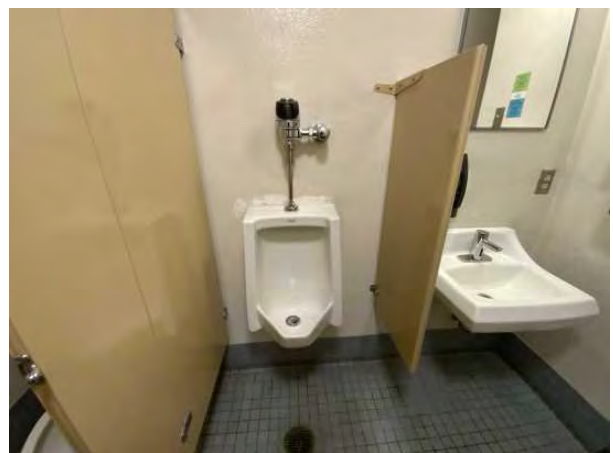
Photos for Barrier ID: AX298697

Assembly	Restroom
Type	Restroom/Bathroom - Urinal
ADA Standard	605.3; 305
Barrier Detail	The clear floor space at the urinal is less than minimum 30" by minimum 48".
Location Description	Men's Restroom
Observed	Oct 16, 2022 by Justin.vang@bureauveritas.com
Site Conditions	The depth of the clear floor space is 36".

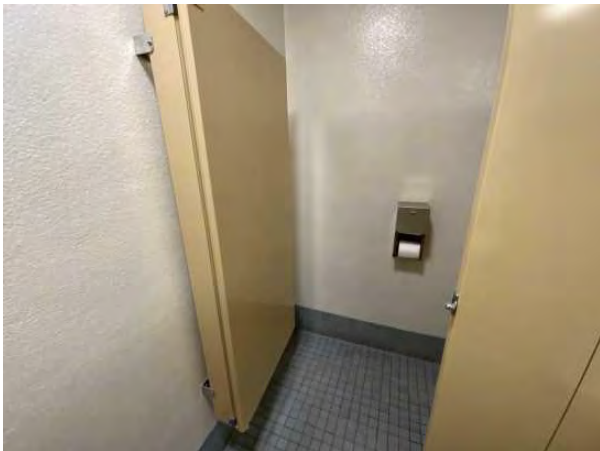
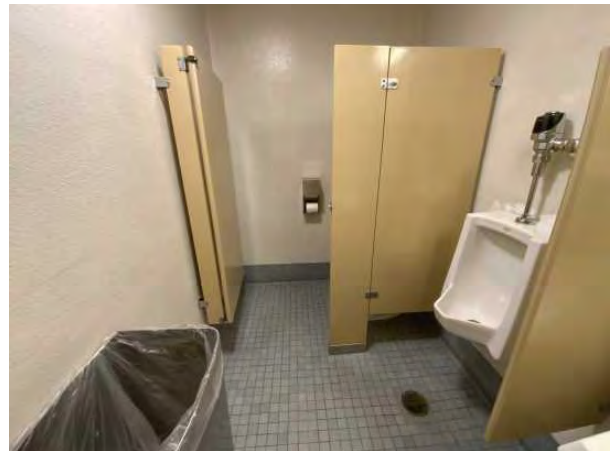
Photos for Barrier ID: AX298699

Assembly	Restroom
Type	Restroom/Bathroom - Door
ADA Standard	309, 404.2.7, 604.8.1.2
Barrier Detail	The hardware at the wheelchair stall door is not compliant.
Location Description	Men's Restroom
Observed	Oct 16, 2022 by Justin.vang@bureauveritas.com
Site Conditions	U-pulls are not provided on both side of the stall door.

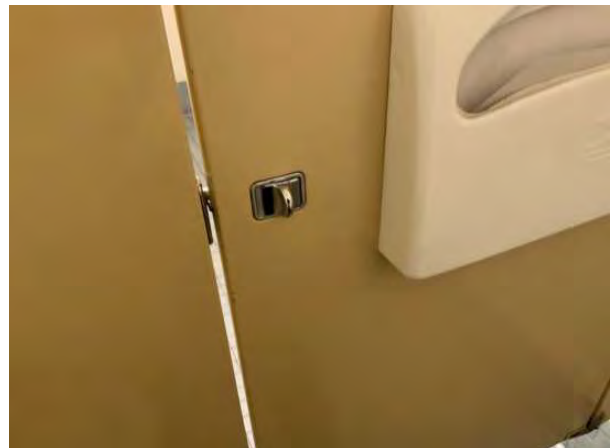
Photos for Barrier ID: AX298700

Assembly	Restroom
Type	Restroom/Bathroom-Water Closet
ADA Standard	CBC Chap 11B-404, 604.8.1.2
Barrier Detail	CALIFORNIA: The toilet stall door is not compliant.
Location Description	Men's Restroom
Observed	Oct 16, 2022 by Justin.vang@bureauveritas.com
Site Conditions	The stall door width is 24-1/2".

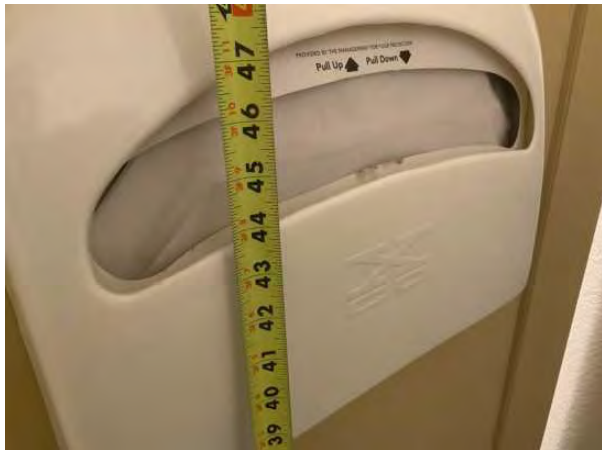
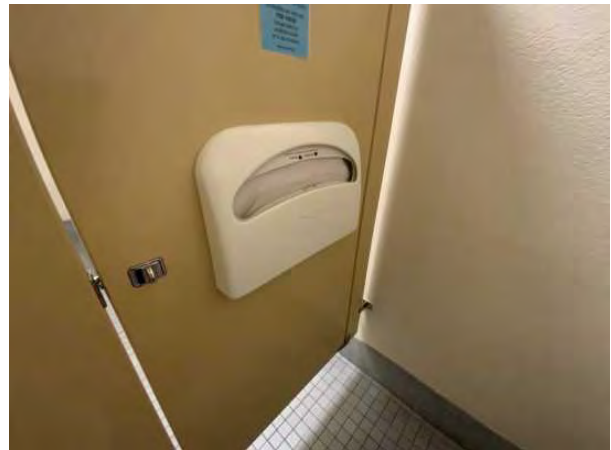
Photos for Barrier ID: AX298704

Assembly	Restroom
Type	Restroom/Bathroom - Water Closet
ADA Standard	604.5.2
Barrier Detail	The grab bars at the water closet are not compliant.
Location Description	Men's Restroom
Observed	Oct 16, 2022 by Justin.vang@bureauveritas.com
Site Conditions	A rear grab bar and side grab bar is not provided.

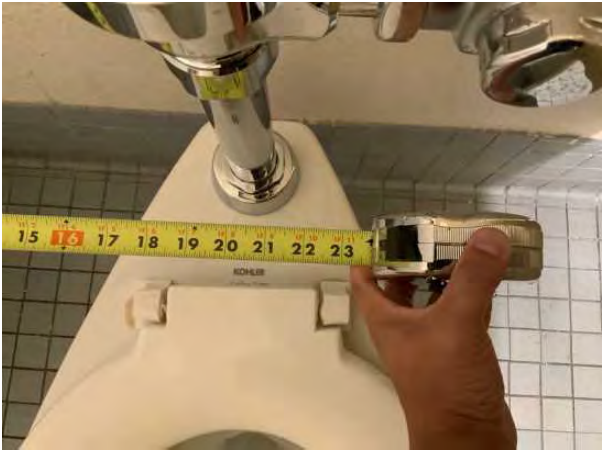
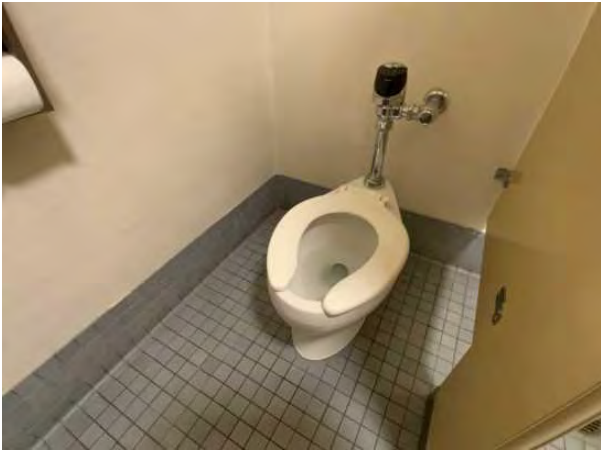
Assembly	Restroom
Type	Restroom/Bathroom - Water Closet
ADA Standard	CBC Chap 11B-604.7, 604.9, 609.3
Barrier Detail	CALIFORNIA: The toilet paper dispenser is not compliant.
Location Description	Men's Restroom
Observed	Oct 16, 2022 by Justin.vang@bureauveritas.com
Site Conditions	The paper towel dispenser is directly adjacent to the toilet.

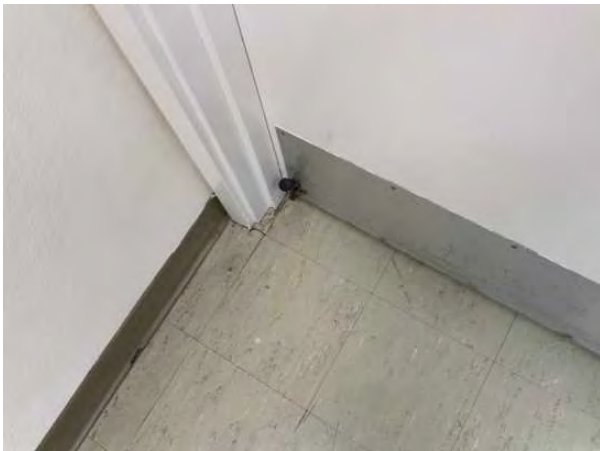
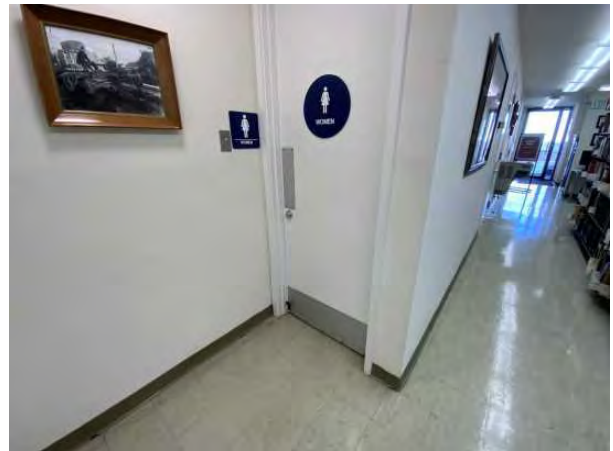
Photos for Barrier ID: AX298676

Assembly	Restroom
Type	Restroom/Bathroom - Door
ADA Standard	404.2.3
Barrier Detail	The door has less than 32" clear width
Location Description	Women's Restroom
Observed	Oct 16, 2022 by Justin.vang@bureauveritas.com
Site Conditions	The door width is 27-1/2".

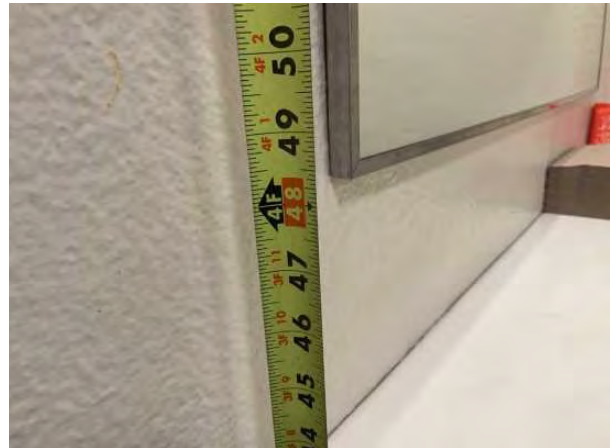
Photos for Barrier ID: AX298680

Assembly	Restroom
Type	Restroom/Bathroom - Floor Space
ADA Standard	304, 603.2.1; 603.2.2
Barrier Detail	The required turning space within the restroom is not provided.
Location Description	Women's Restroom
Observed	Oct 16, 2022 by Justin.vang@bureauveritas.com
Site Conditions	The turning space is 54-1/4" wide.

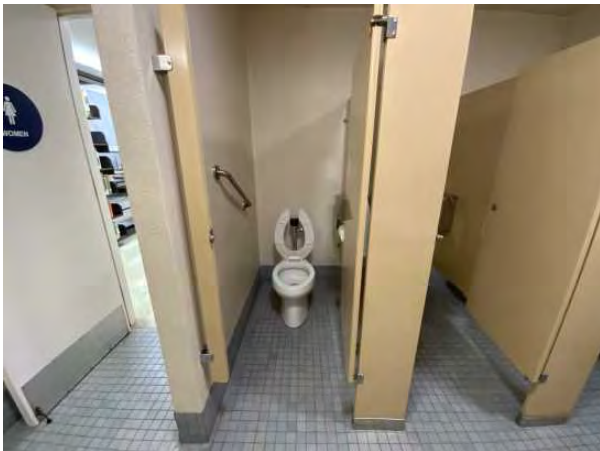
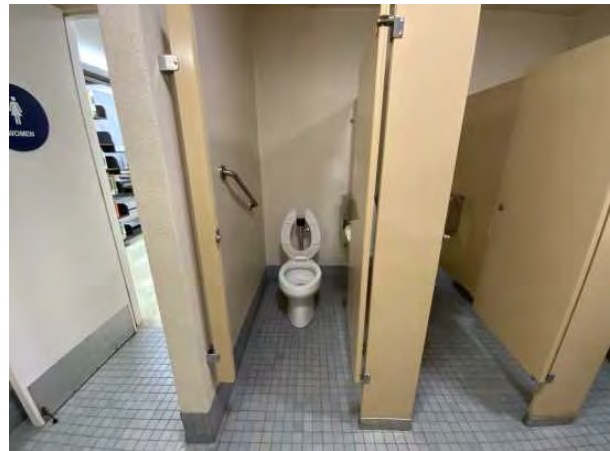
Photos for Barrier ID: AX298709

Assembly	Restroom
Type	Restroom/Bathroom - Door
ADA Standard	309, 404.2.7, 604.8.1.2
Barrier Detail	The hardware at the wheelchair stall door is not compliant.
Location Description	Women's Restroom
Observed	Oct 16, 2022 by Justin.vang@bureauveritas.com
Site Conditions	U-pulls are not provided on both side of the stall door.

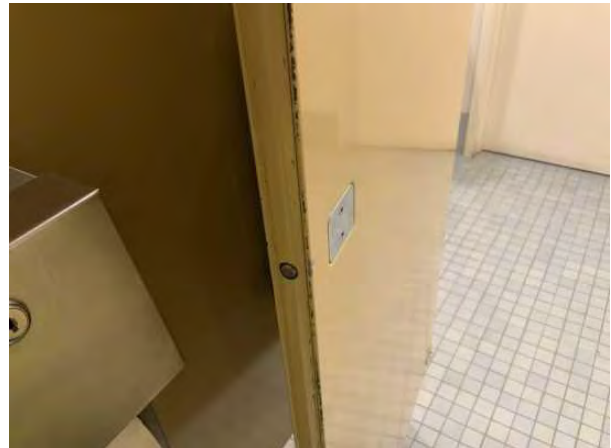
Photos for Barrier ID: AX298710

Assembly	Restroom
Type	Restroom/Bathroom-Water Closet
ADA Standard	CBC Chap 11B-404, 604.8.1.2
Barrier Detail	CALIFORNIA: The toilet stall door is not compliant.
Location Description	Women's Restroom
Observed	Oct 16, 2022 by Justin.vang@bureauveritas.com
Site Conditions	The stall door width is 22".

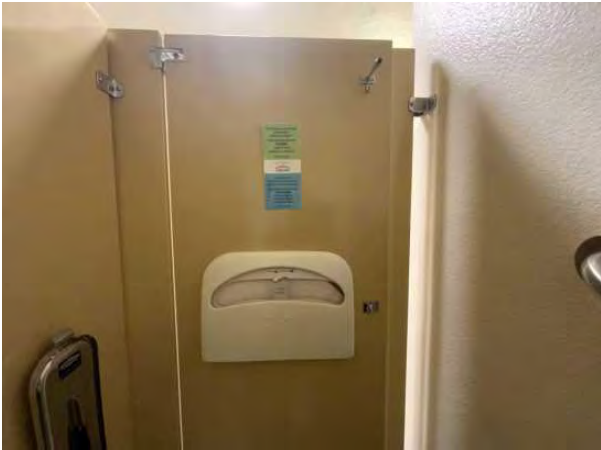
Assembly	Restroom
Type	Controls And Dispensers
ADA Standard	California Building Code Chap 11B-603.5
Barrier Detail	CALIFORNIA: Dispensers in restrooms are not located maximum 40" AFF.
Location Description	Women's Restroom
Observed	Oct 16, 2022 by Justin.vang@bureauveritas.com
Site Conditions	The operable part at the seat cover dispenser is 44" high.
