## **ASBESTOS SURVEY REPORT**

#### 6/12/2018

Sonoma County Library 725 3rd St (History Annex) Santa Rosa CA

Re: Asbestos Survey for 725 3rd St (History Annex)

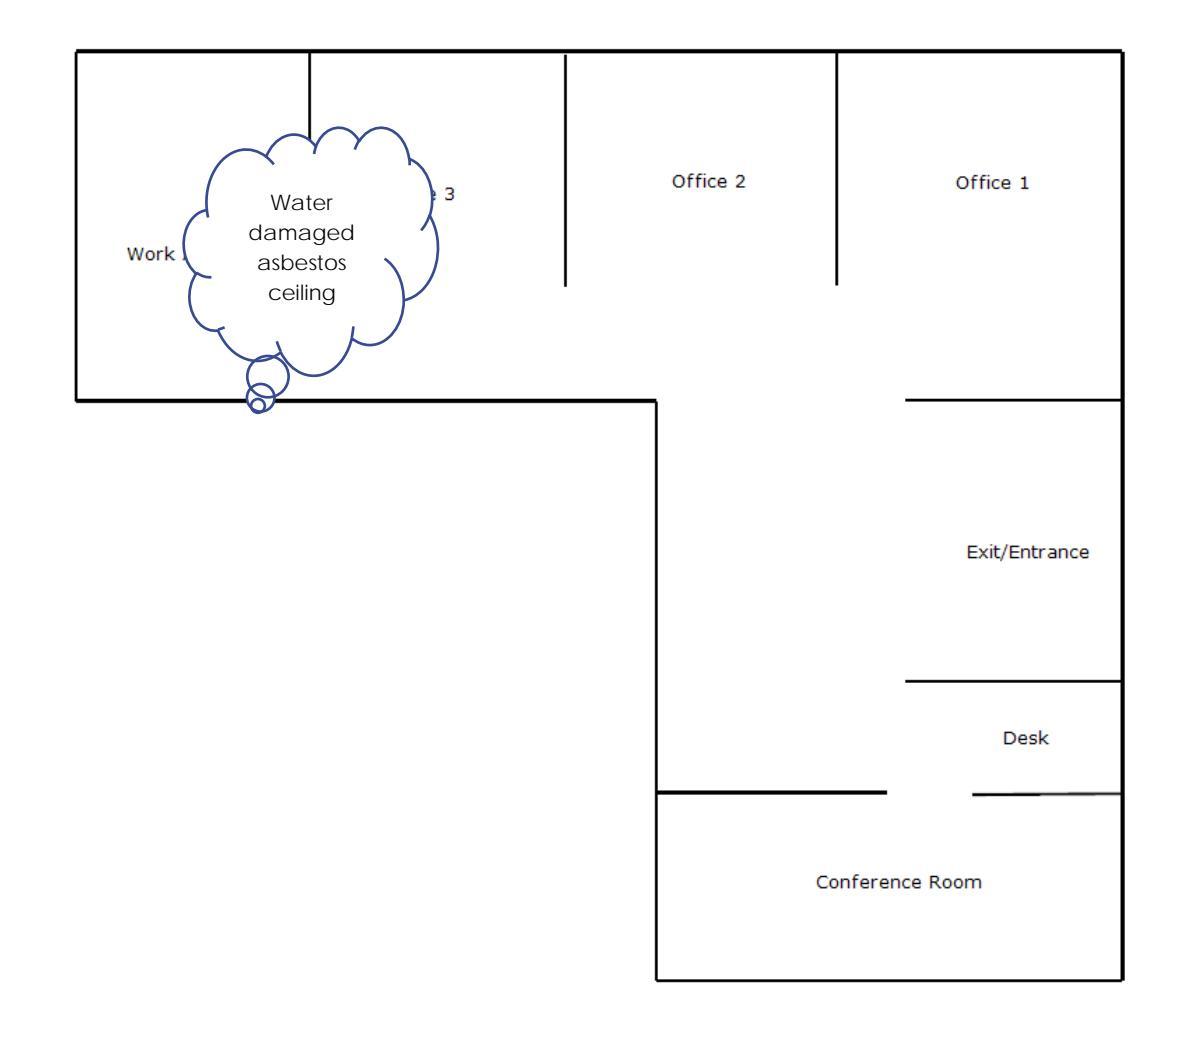
Sketch

The off white acoustical ceiling texture material is water damage in one or more locations and considered a friable asbestos containing material. Based on the presence of asbestos and the existing damage it is our recommendation that you pursue an abatement of this condition promptly.
