Sonoma County Library Annex Building Study

FINAL REPORT | 19 APRIL 2023

FACILITY CONDITION ASSESSMENT

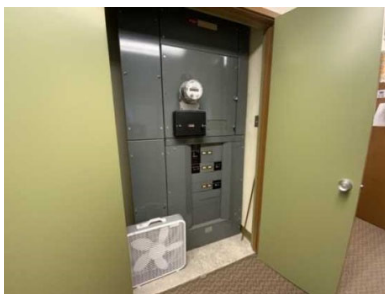
120/208 V
Annex Building Office Area

Switchboard in Poor condition.

Uniformat Code: D5020
Recommendation: **Replace in 2024**

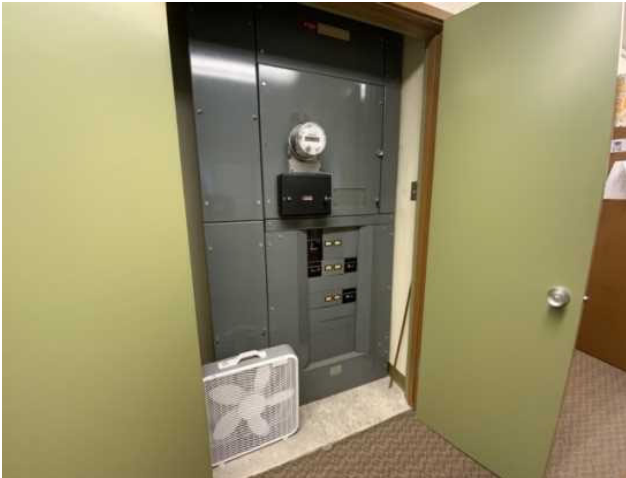
21 - SWITCHBOARD

BV’s report does describe the HVAC system as “antiquated.” BV also notes that “... much of the electrical infrastructure is original. Although no problems are reported, [this type and make of switchboard panel have] a high risk for unexpected failure.” BV recommends significant upgrades to the electrical system and a new boiler within the next three to five years.

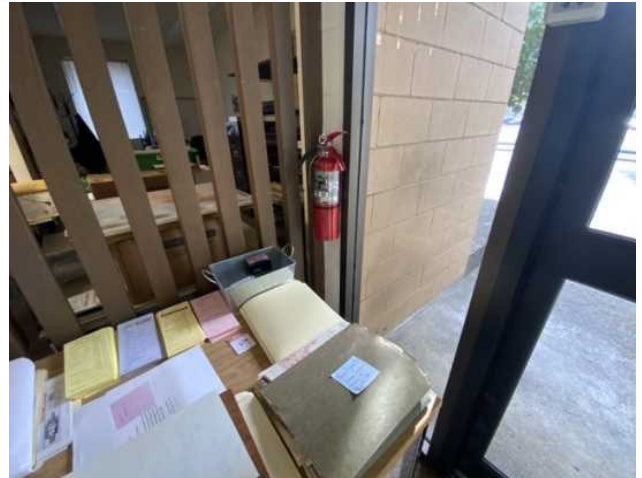
22 - FIRE EXTINGUISHER

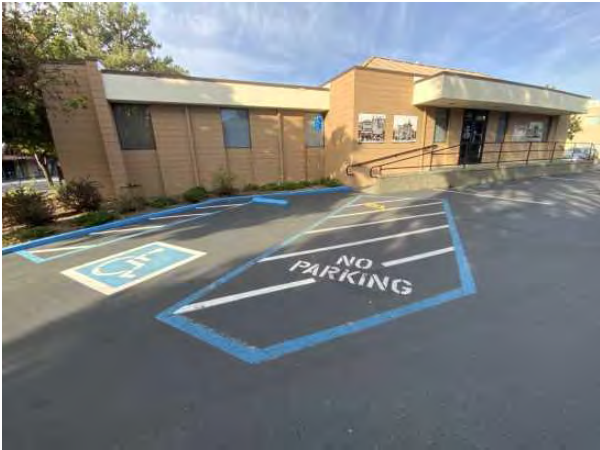
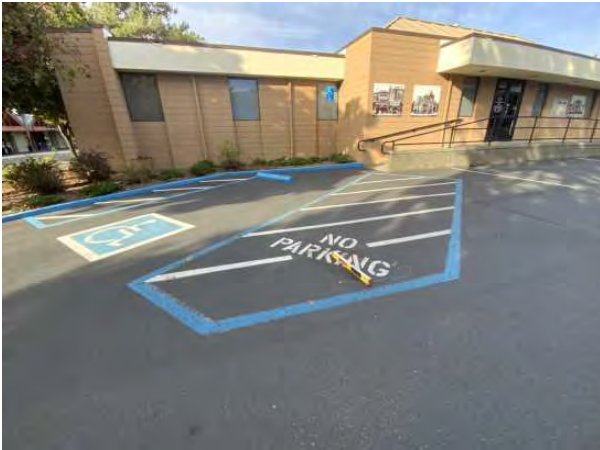
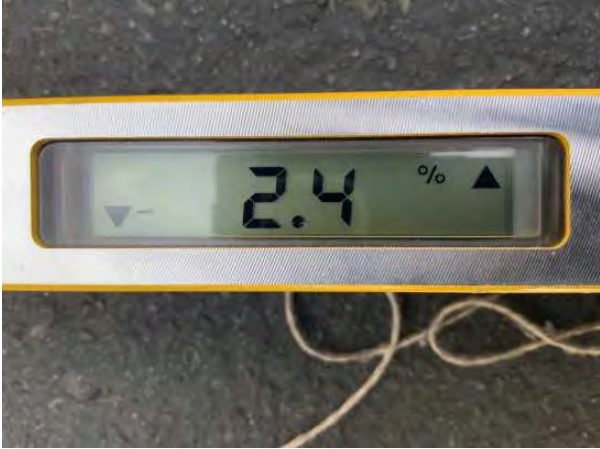
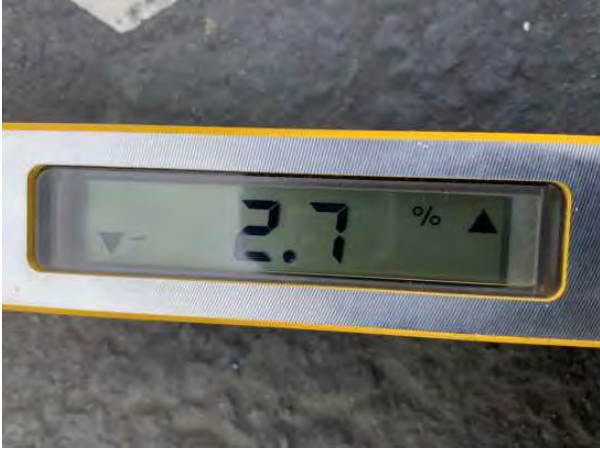
Map for Barrier ID: AX298640

Central Library Annex EXTERIOR

Assembly	Accessible Parking
Type	Parking Space - Van
ADA Standard	California Building Code Chap 11B-502.4
Barrier Detail	CALIFORNIA: The van parking stall slope is greater than 1:48 (2.08%).
Location Description	Accessible Parking Space P1
Observed	Oct 16, 2022 by Justin.vang@bureauveritas.com
Site Conditions	The parking stall slope is 2.5% - 4.4%.

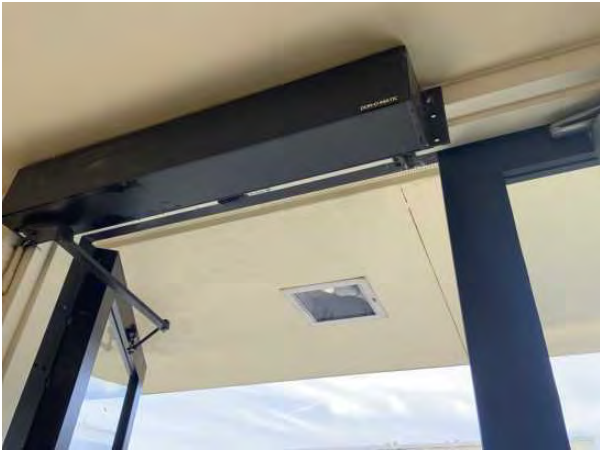
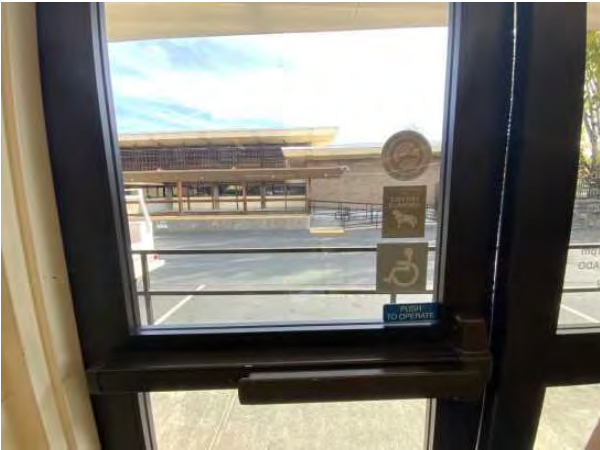
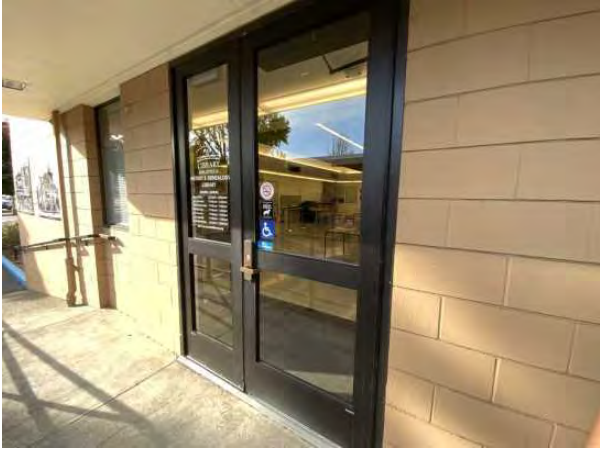
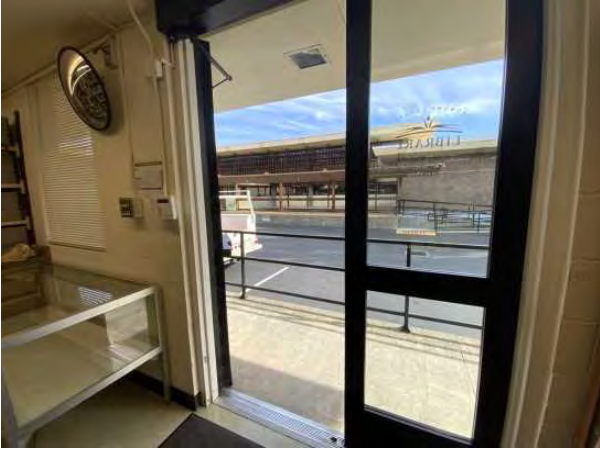
Map for Barrier ID: AX298656

Central Library Annex INTERIOR

Assembly	Entrance to Building
Type	Building Entrance - Door
ADA Standard	404.2.5
Barrier Detail	The threshold at the accessible door is greater than ½" in height.
Location Description	Main Entrance
Observed	Oct 16, 2022 by Justin.vang@bureauveritas.com
Site Conditions	The threshold is 1" high.

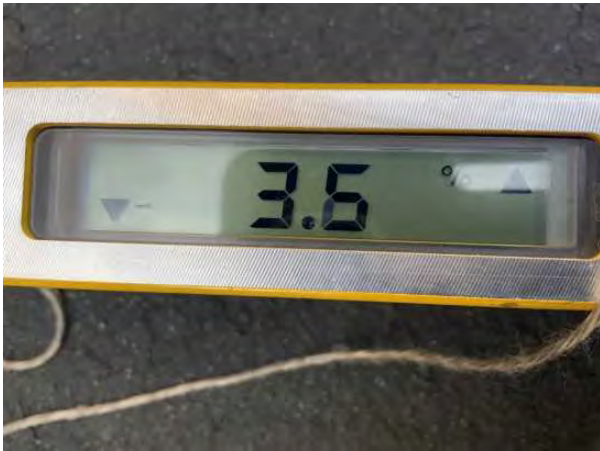
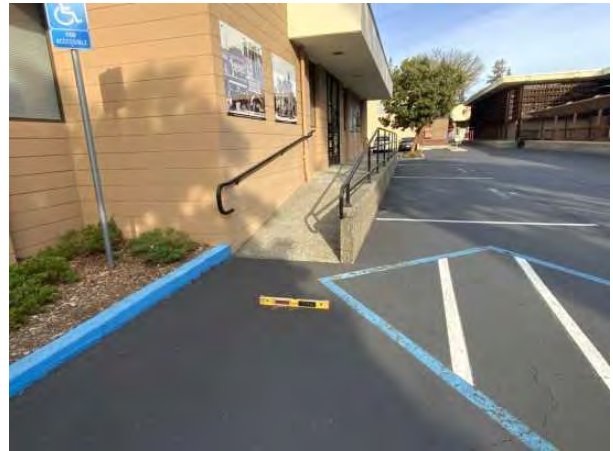
Photos for Barrier ID: AX298641

Central Library Annex EXTERIOR

Assembly	Exterior Access Route
Type	Ramp
ADA Standard	303

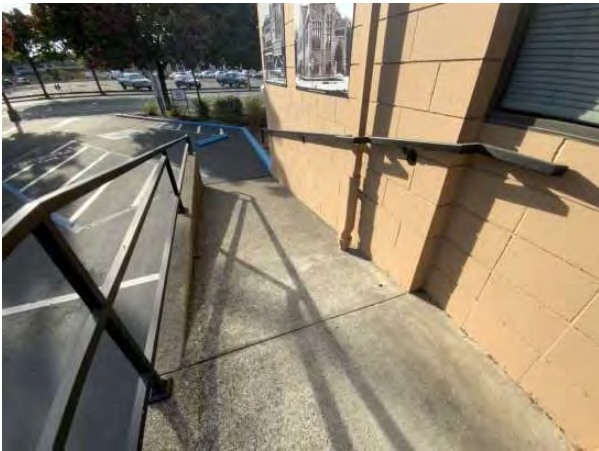
Photos for Barrier ID: AX298644

Central Library Annex EXTERIOR

Assembly	Exterior Access Route
Type	Ramp
ADA Standard	California Building Code Chap 11B-Chap 11B-405.3
Barrier Detail	CALIFORNIA: The exterior ramp is less than 48" wide.
Location Description	Ramp R1
Observed	Oct 16, 2022 by Justin.vang@bureauveritas.com
Site Conditions	The pipe reduces the ramp clear width to 47-1/2".

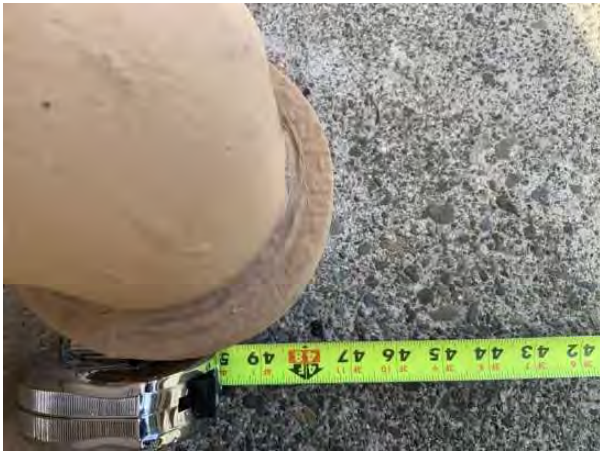
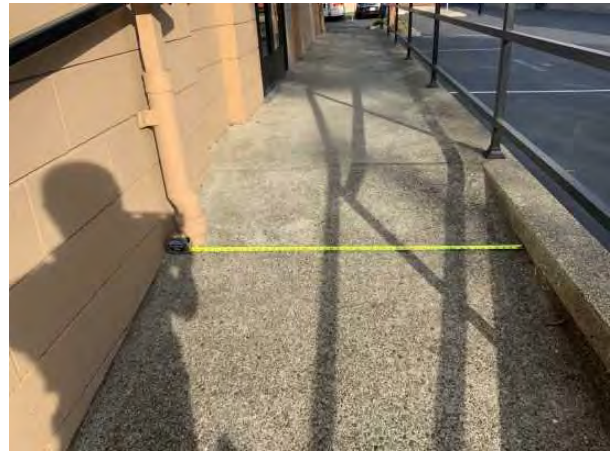
Photos for Barrier ID: AX298646

Central Library Annex EXTERIOR

Assembly	Exterior Access Route
Type	Ramp
ADA Standard	California Building Code Chap 11B-505.10.1

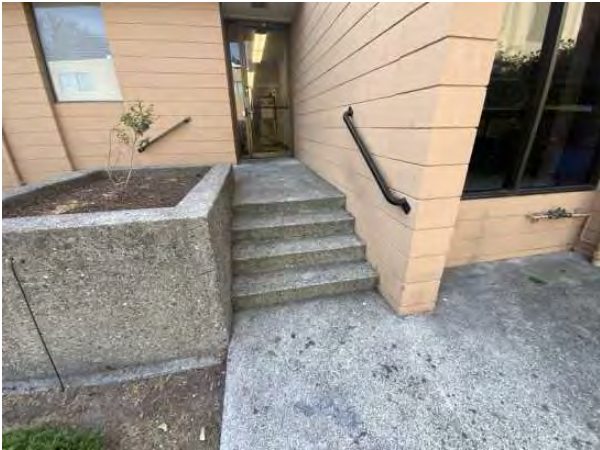
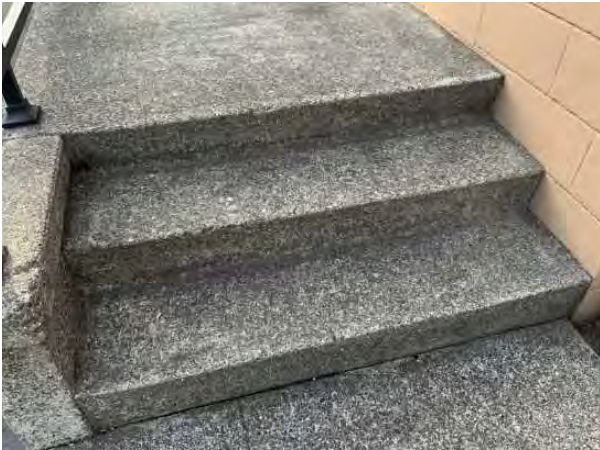
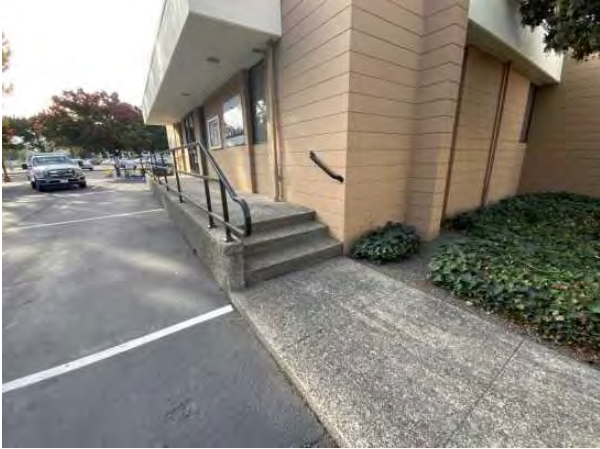
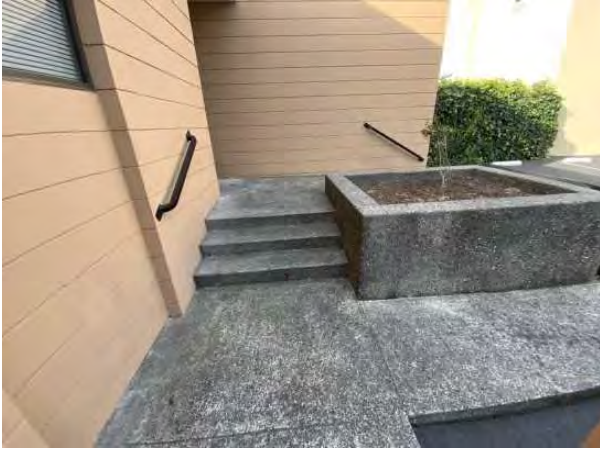
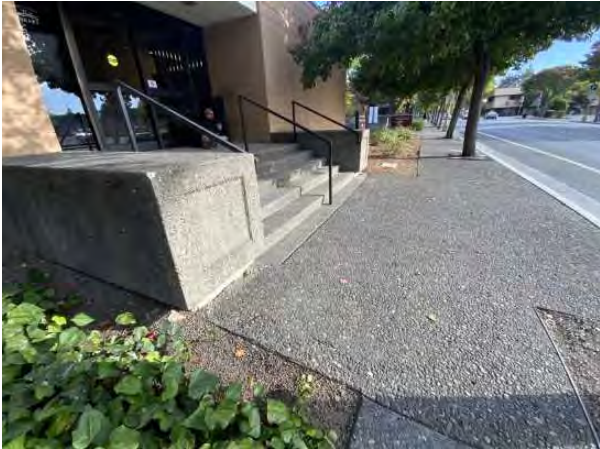
Location Description	Stairs ST1, ST2, ST3, and ST4
Observed	Oct 16, 2022 by Justin.vang@bureauveritas.com
Site Conditions	A clear stripe is not provided at each tread nosing.

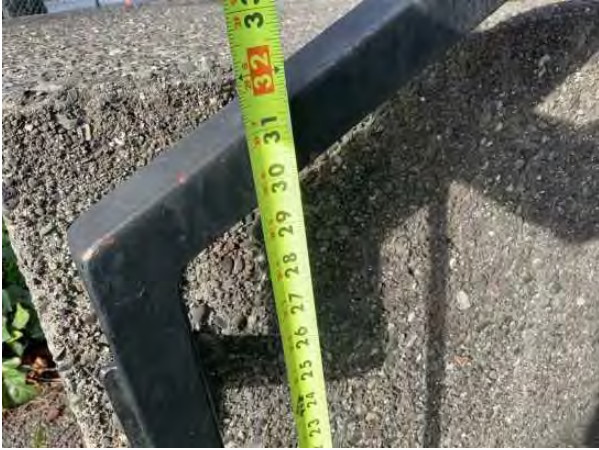
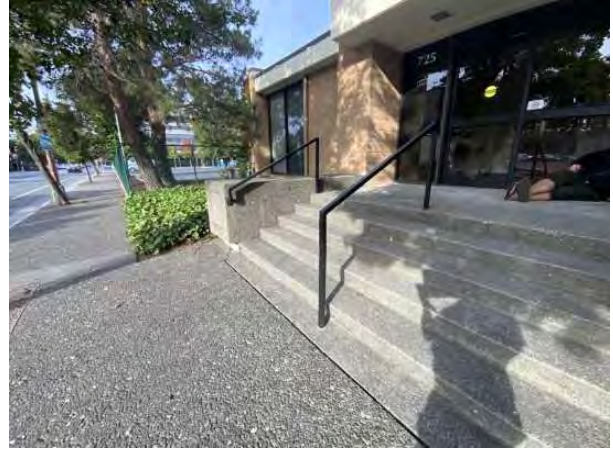
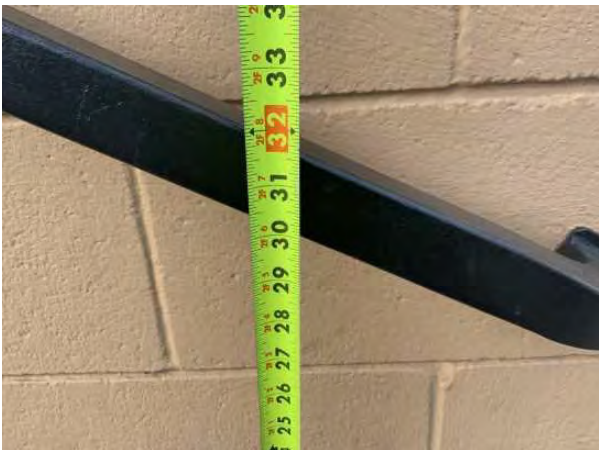
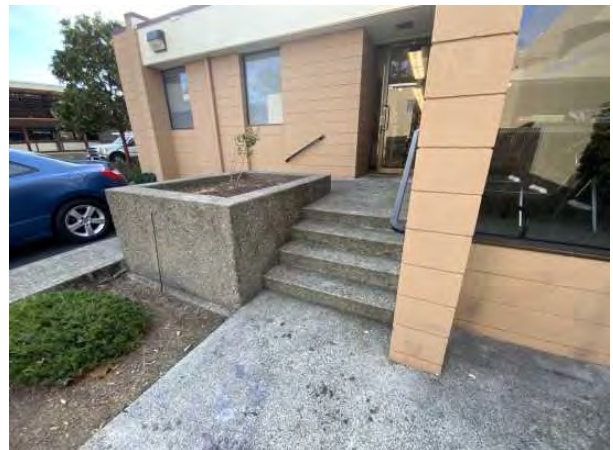
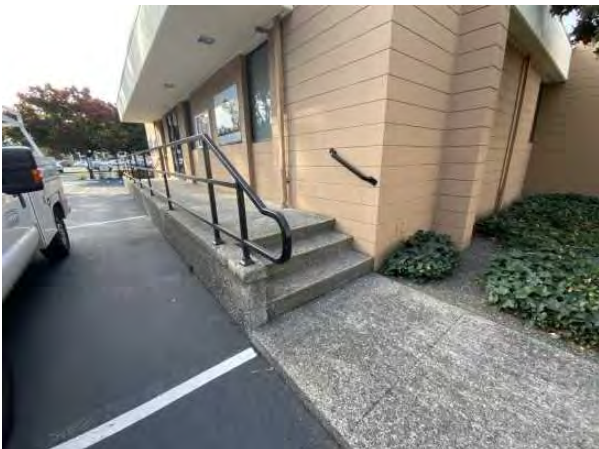
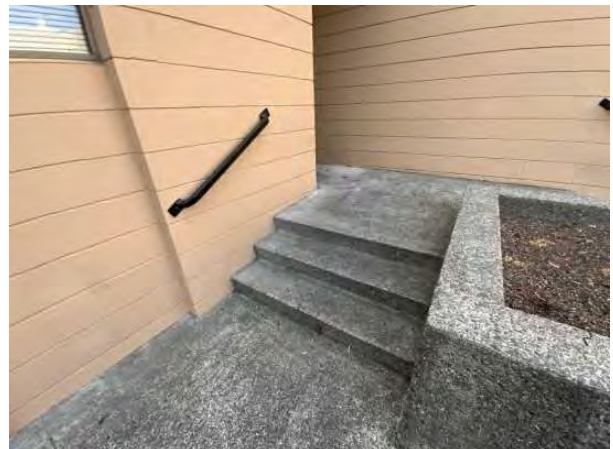
Photos for Barrier ID: AX298650

Assembly	Exterior Access Route
Type	Stairs
ADA Standard	CBC Chap 11B-505
Barrier Detail	CALIFORNIA: Handrails are not compliant or are not provided.
Location Description	Stairs ST1, ST2, ST3, and ST4
Observed	Oct 16, 2022 by Justin.vang@bureauveritas.com

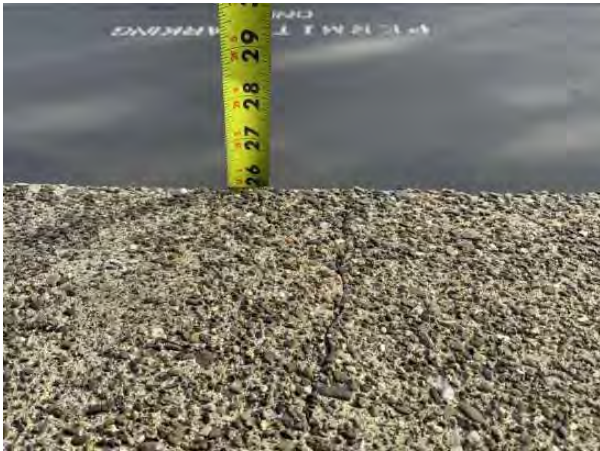
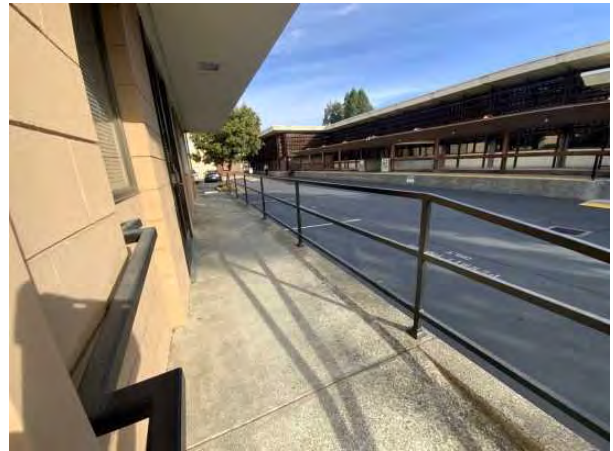
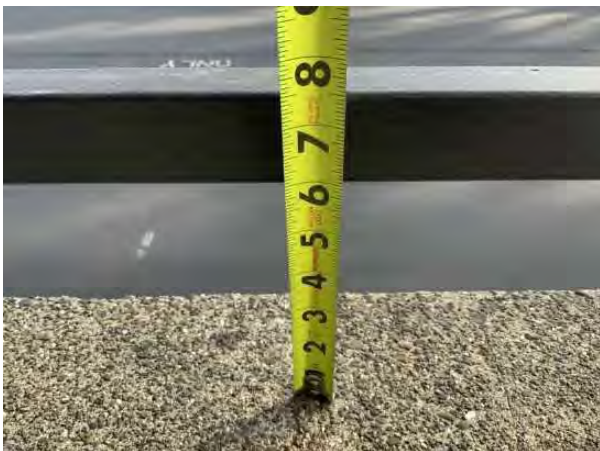
Photos for Barrier ID: AX298648

Location Description	Walkway at Main Entrance
Observed	Oct 16, 2022 by Justin.vang@bureauveritas.com
Site Conditions	The center of the guide rail is 7" above the walkway.

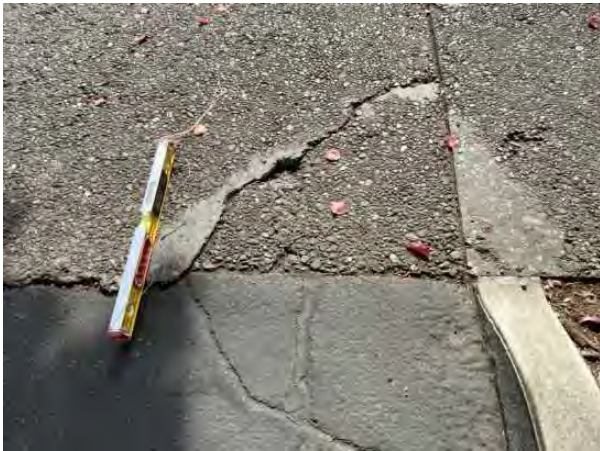
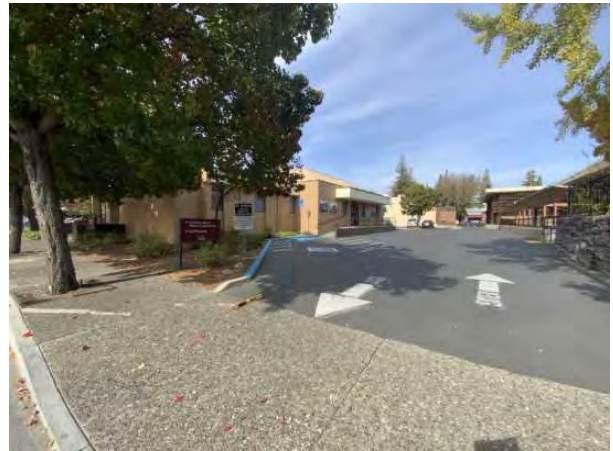
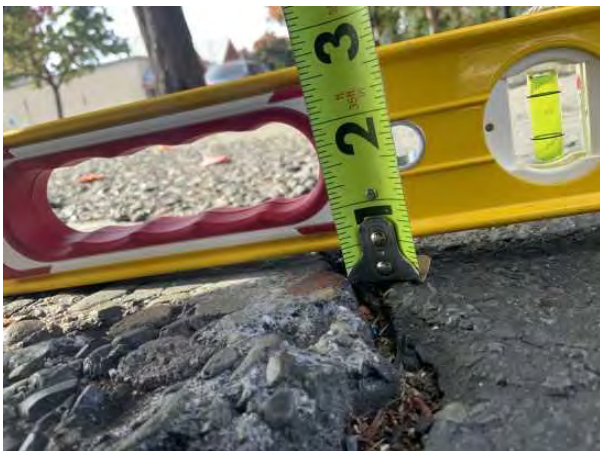
Photos for Barrier ID: AX298652

Location Description	Walkway from 3rd Street to Access Aisle serving P1
Observed	Oct 16, 2022 by Justin.vang@bureauveritas.com
Site Conditions	The walkway has a 1/2" high vertical change in level.

The sidewalk should be removed (sections that are heaved, cracked etc) and repaired. Changes in level of 1/4" high maximum shall be permitted to be vertical. Changes in level between 1/4" high minimum and 1/2" high maximum shall be beveled with a slope not steeper than 1:2. Changes in level greater than 1/2" shall be ramped.

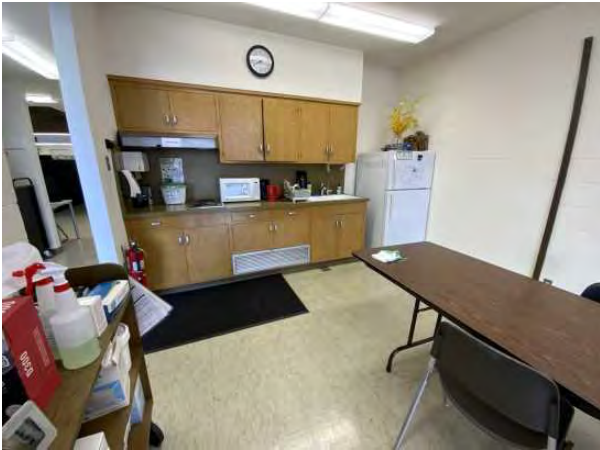
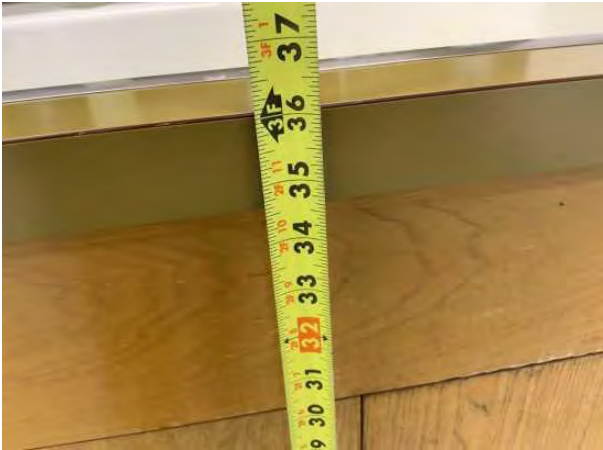
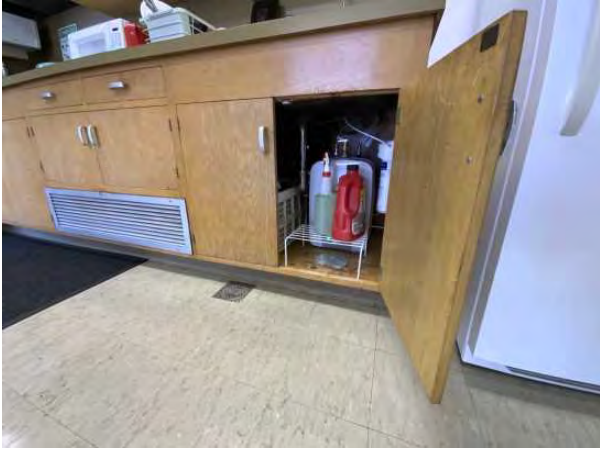
Location Description	Break Room
Observed	Oct 16, 2022 by Justin.vang@bureauveritas.com
Site Conditions	The sink rim height is 36-1/2". The sink does not provide knee clearance.

Relocate sink to compliant height with knee and toe clearances. Lavatories and sinks shall be installed with the front of the higher of the rim or counter surface 34" maximum above the finish floor or ground. Knee Clearance: Space under an element between 9" and 27" above the finish floor or ground shall be considered knee clearance. Knee clearance shall extend 25" maximum under an element at 9" above the finish floor or ground. Where knee clearance is required under an element as part of a clear floor space, the knee clearance shall be 11" deep minimum at 9" above the finish floor or ground, and 8" deep minimum at 27" above the finish floor or ground. Between 9" and 27" above the finish floor or ground, the knee clearance shall be permitted to reduce at a rate of 1" in depth for each 6" in height. Knee clearance shall be 30" wide minimum. Toe Clearance: Space under an element between the finish floor or ground and 9" above the finish floor or ground shall be considered toe clearance. Toe clearance shall extend 25" maximum under an element. Where toe clearance is required at an element as part of a clear floor space, the toe clearance shall extend 17" minimum under the element. Space extending greater than 6" beyond the available knee clearance at 9" above the finish floor or ground shall not be considered toe clearance. Toe clearance shall be 30" wide minimum.

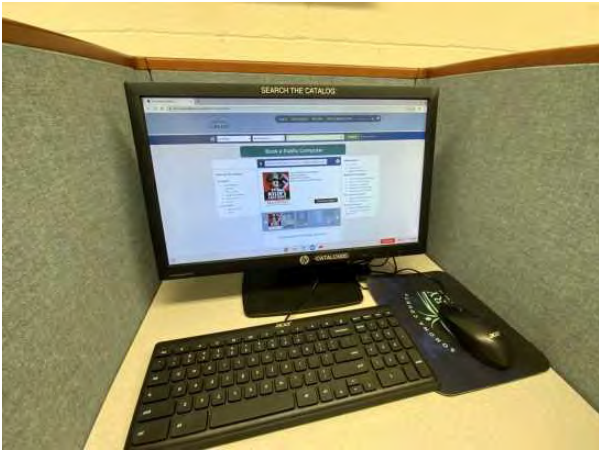
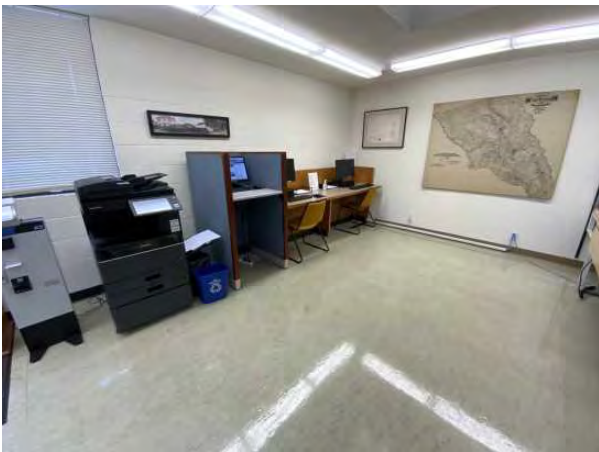
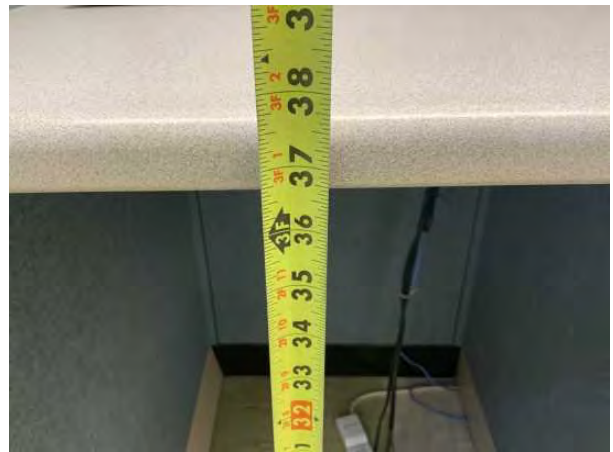
Assembly	Interior Access Route
Type	Dining And Work Surface
ADA Standard	CBC Chap 11B-306, 902
Barrier Detail	CALIFORNIA: The dining or work surface is not compliant.
Location Description	Catalog Computers
Observed	Oct 16, 2022 by Justin.vang@bureauveritas.com

Install a dining or work surface minimum 28" to maximum 34" height with clear space and compliant knee and toe clearance for a forward approach. Where food or drink is served for consumption at a counter exceeding 34 inches in height, a portion of the main counter 60 inches minimum in length shall be provided in compliance. Dining surfaces required to comply shall be dispersed throughout the space or facility containing dining surfaces for each type of seating in a functional area. Work surfaces required to comply shall be dispersed throughout the space or facility containing work surfaces. Where dining surfaces are provided for the consumption of food or drink, at least 5 percent of the seating spaces and standing spaces at the dining surfaces shall comply. Where work surfaces are provided for use by other than employees, at least 5 percent shall comply. [EXCEPTIONS: 1. Sales counters and service counters shall not be required to comply. 2. Check writing surfaces provided at check-out aisles not required to be accessible shall not be required to comply.] Clear space shall be maximum 1:48 (2.08%) in all directions and a firm and stable surface. Knee Clearance: Space under an element between 9" and 27" above the finish floor or ground shall be considered knee clearance. Knee clearance shall extend 25 inches maximum under an element at 9" above the finish floor or ground. Where knee clearance is required under an element as part of a clear floor space, the knee clearance shall be 11" deep minimum at 9" above the finish floor or ground. At dining and work surfaces required to be accessible, knee clearance shall extend 19 inches deep minimum at 27 inches above the finish floor or ground. The knee clearance shall not be reduced at built-in dining and work surfaces required to be accessible. Knee clearance shall be 30" wide minimum. Toe Clearance: Space under an element between the finish floor or ground and 9" above the finish floor or ground shall be considered toe clearance. Toe clearance shall extend 25" maximum under an element. Space extending greater than 6" beyond the available knee clearance at 9" above the finish floor or ground shall not be considered toe clearance. Toe clearance shall be 30" wide minimum. The toe clearance shall extend 19 inches minimum under built-in dining and work surfaces required to be accessible.

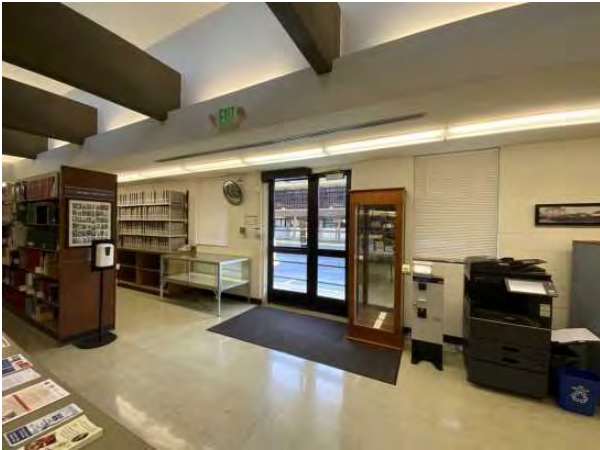
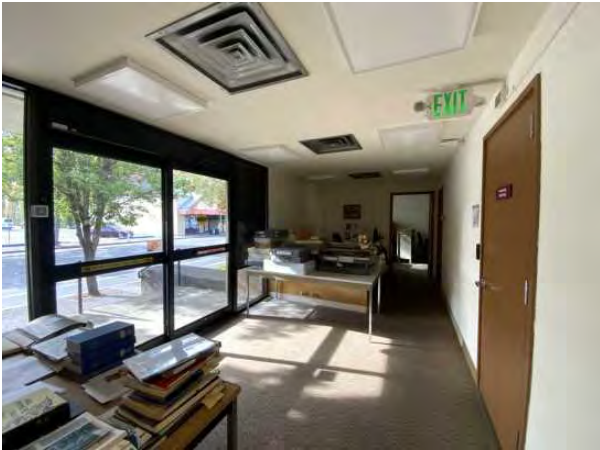
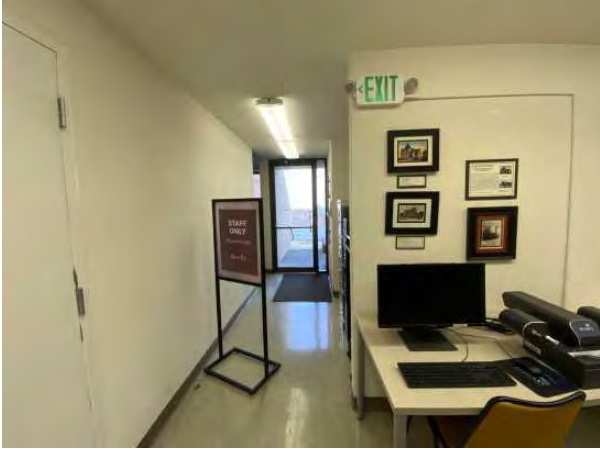
Assembly	Interior Access Route
Type	Signage
ADA Standard	703.1, 703.4
Barrier Detail	Means of egress signage does not have tactile lettering.
Location Description	Egress Doors
Observed	Oct 16, 2022 by Justin.vang@bureauveritas.com
Site Conditions	Tactile means of egress signs are not provided.

Provide compliant means of egress signage at each exit passageway, exit discharge, and exit stairway. Signs at designated egress passageways, stairways, exit doors and areas of refuge shall include tactile signage. Signs shall be installed alongside the door at the latch side. [EXCEPTION: Signs with tactile characters shall be permitted on the push side of doors with closers and without hold-open devices.] Where a tactile sign is provided at double doors with one active leaf, the sign shall be located on the inactive leaf. Where a tactile sign is provided at double doors with two active leaves, the sign shall be located to the right of the right hand door. Where there is no wall space at the latch side of a single door or at the right side of double doors, sign shall be located on the nearest adjacent wall. Where both visual and tactile characters are required, either one sign with both visual and tactile characters, or two separate signs, one with visual, and one with tactile characters, shall be provided. Signs containing tactile characters shall be located so that clear floor space of 18" minimum by 18" minimum, centered on the tactile characters, is provided beyond the arc of any door swing between the closed position and 45 degrees open. Raised characters shall be complaint and shall be duplicated in Braille. Raised characters shall be as follows- Depth: Raised characters shall be 1/32" minimum above their background. Case: Characters shall be uppercase. Style" Characters shall be sans serif. Characters shall not be italic, oblique, script, highly decorative, or of other unusual forms. Character Proportions: Characters shall be selected from fonts where the width of the uppercase letter "O" is 55 % minimum and 110 % maximum of the height of the uppercase letter "I". Character Height. Character height measured vertically from the baseline of the character shall be 5/8" minimum and 2" maximum based on the height of the uppercase letter "I". [EXCEPTION: Where separate raised and visual characters with the same information are provided, raised character height shall be permitted to be 1/2" minimum.]

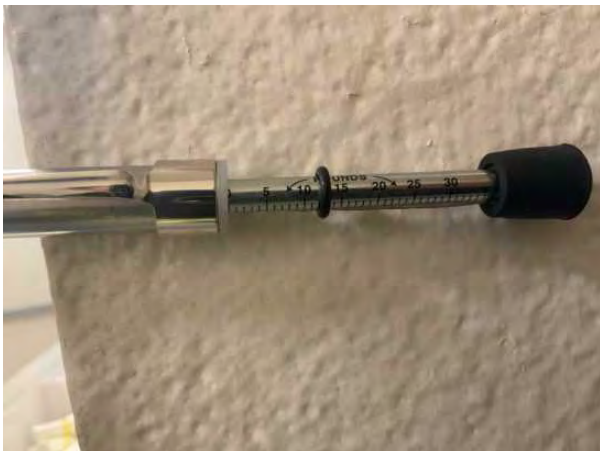
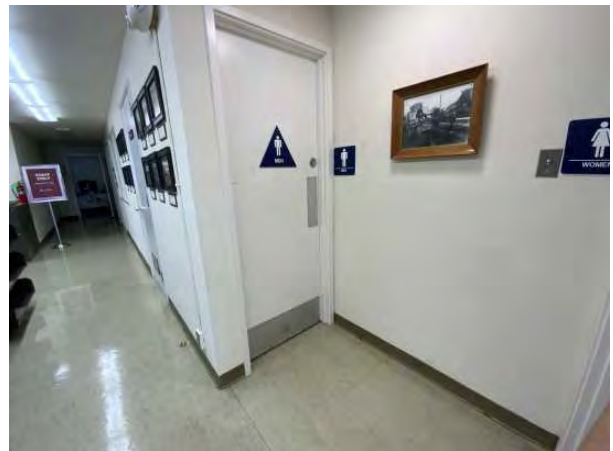
Photos for Barrier ID: AX298687

Assembly	Restroom
Type	Restroom/Bathroom - Door
ADA Standard	404.2.8

Location Description	Men's Restroom
Observed	Oct 16, 2022 by Justin.vang@bureauveritas.com

Adjust closer or remove and replace closer to ensure that the door has a closure time of at least 5 seconds within 12 degrees of the latch. This barrier must be removed in conjunction with barrier ID 298687. The cost of this barrier removal is covered under barrier ID 298687 and therefore, the cost is shown as \$0. Door closers and gate closers shall be adjusted so that from an open position of 90 degrees, the time required to move the door to a position of 12 degrees from the latch is 5 seconds minimum.

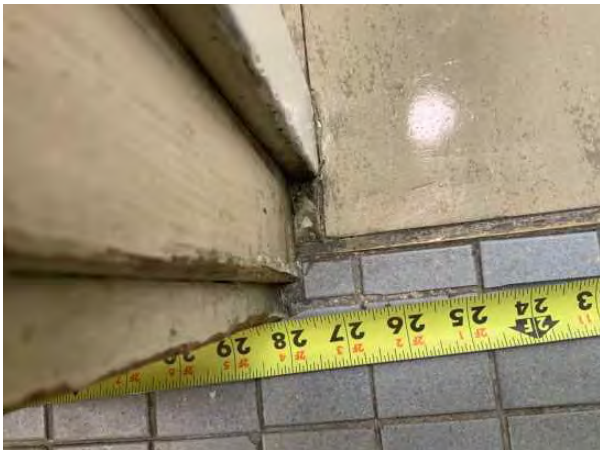
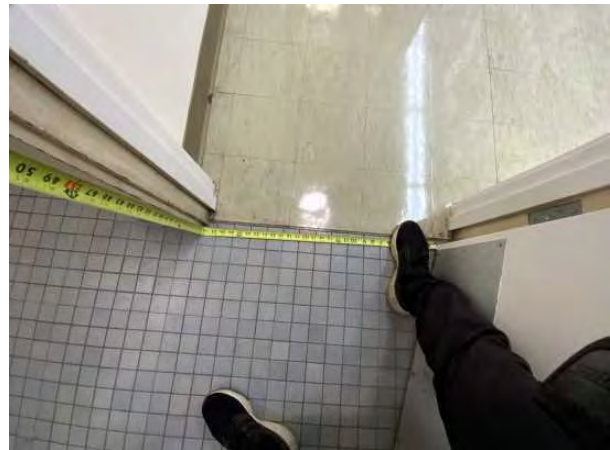
Photos for Barrier ID: AX298689

Assembly	Restroom
Type	Restroom/Bathroom - Door
ADA Standard	404.2; Table 404.2.4.1

Location Description	Men's Restroom
Observed	Oct 16, 2022 by Justin.vang@bureauveritas.com
Site Conditions	The maneuvering clearance perpendicular to the door is 34".

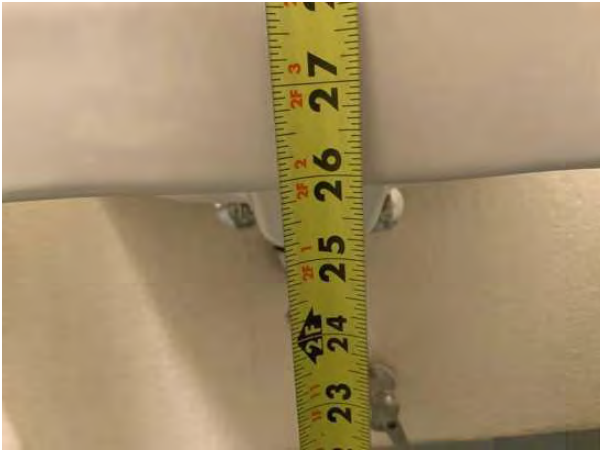
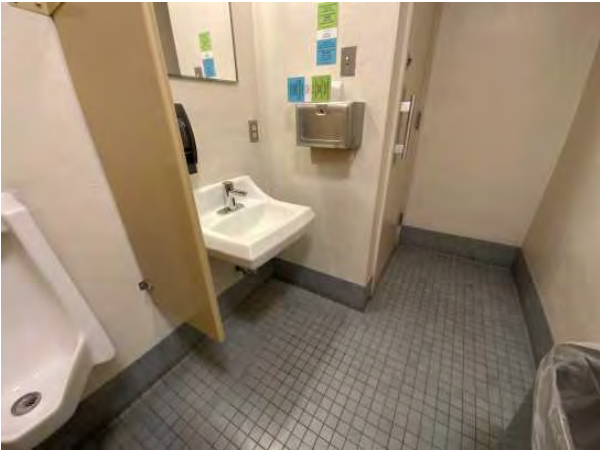
Assembly	Restroom
Type	Restroom/Bathroom - Lavatory
ADA Standard	CBC Chap 11B-606.6; 305

Location Description	Men's Restroom
Observed	Oct 16, 2022 by Justin.vang@bureauveritas.com
Site Conditions	The lavatory centerline is 16-1/2" from the side wall and partition.

Relocate the lavatory to provide minimum 18" from the side partition/wall to centerline of lavatory. The height of the lavatory to the higher of the rim or counter surface shall be 34" maximum AFF. Provide minimum 30" by minimum 48" clear floor space positioned for a parallel or front approach to the lavatory. One full unobstructed side of the clear floor or ground space shall adjoin an accessible route or adjoin another clear floor or ground space. Where a clear floor or ground space is located in an alcove or otherwise confined on all or part of three sides, additional maneuvering clearance shall be provided. Alcoves shall be 36" wide minimum where the depth exceeds 24". Alcoves shall be 60" wide minimum where the depth exceeds 15". Floor or ground surfaces of a clear floor or ground space shall comply with 302. Changes in level are not permitted. [EXCEPTION: Slopes not steeper than 1:48 shall be permitted.]

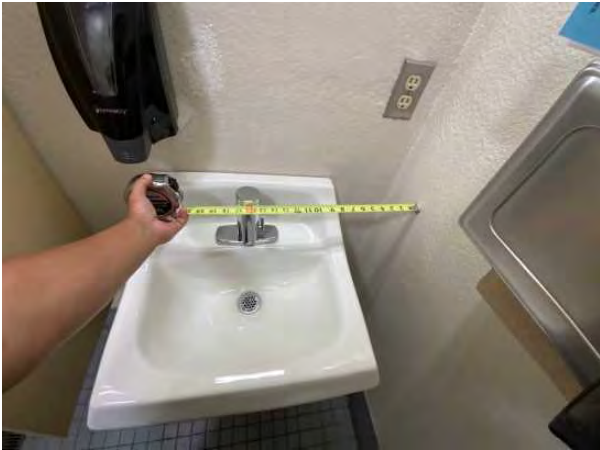
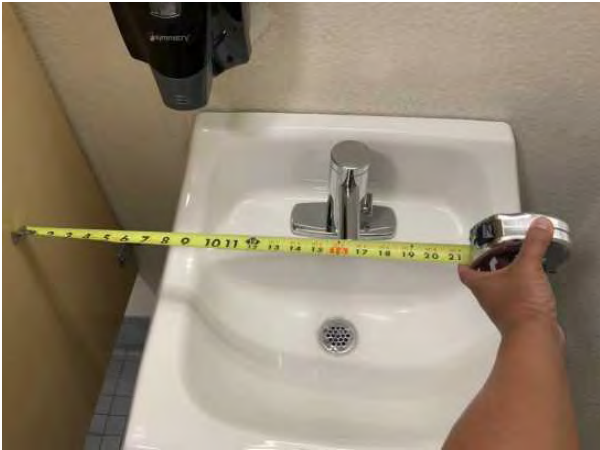
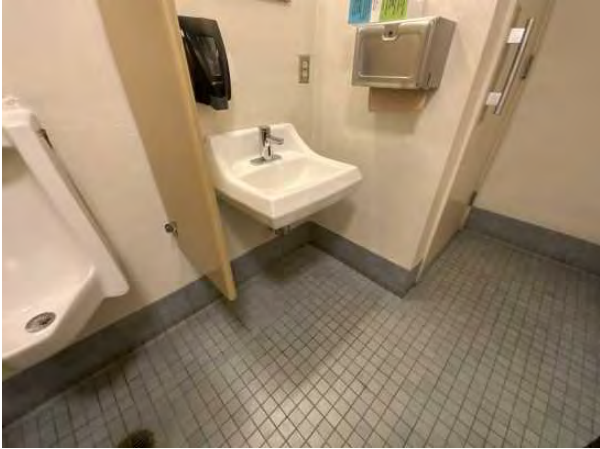
Assembly	Restroom
Type	Restroom/Bathroom - Lavatory
ADA Standard	606.5
Barrier Detail	Pipes are not insulated.
Location Description	Men's Restroom
Observed	Oct 16, 2022 by Justin.vang@bureauveritas.com
Site Conditions	Lavatory drain pipes are not insulated.

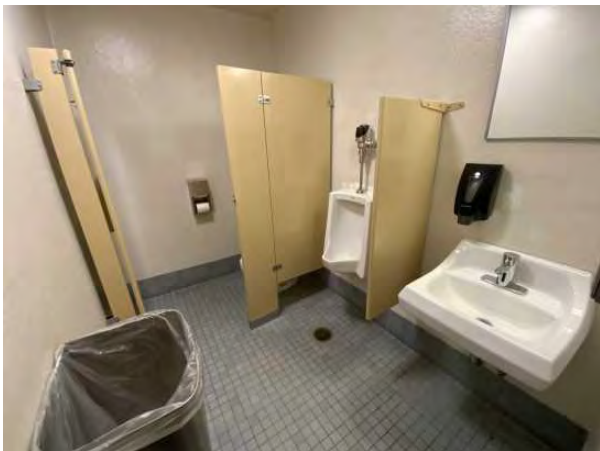
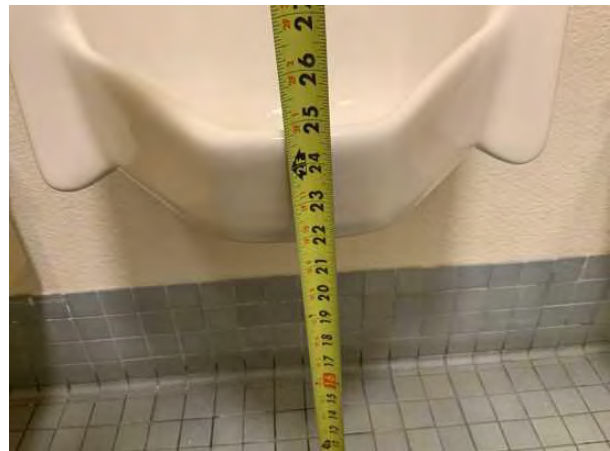
Photos for Barrier ID: AX298696

Assembly	Restroom
Type	Restroom/Bathroom - Urinal
ADA Standard	605.4; 309

Site Conditions	The flush control is 57" high.
------------------------	--------------------------------

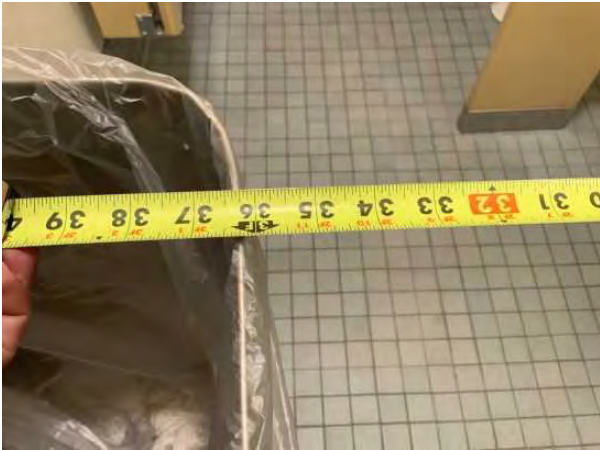
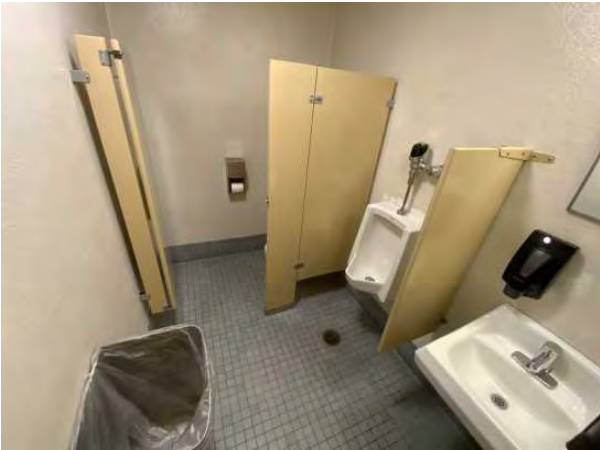
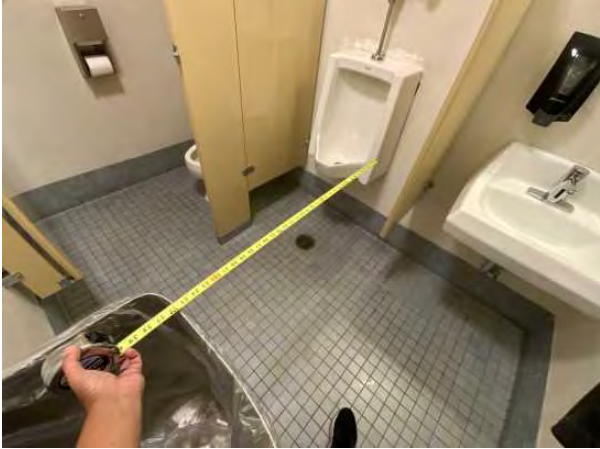
Assembly	Restroom	
Type	Restroom/Bathroom - Water Closet	
ADA Standard	604.8.1.2	
Barrier Detail	The wheelchair stall door is not self closing.	
Location Description	Men's Restroom	
Observed	Oct 16, 2022 by Justin.vang@bureauveritas.com	
Site Conditions	The stall door is not self closing.	
Resolution	Remove hinge hardware and replace with hardware which provides self-closing of the door.	
Quantity	Unit Cost	Total Cost
1 EA	293.00	\$ 293
Priority	3

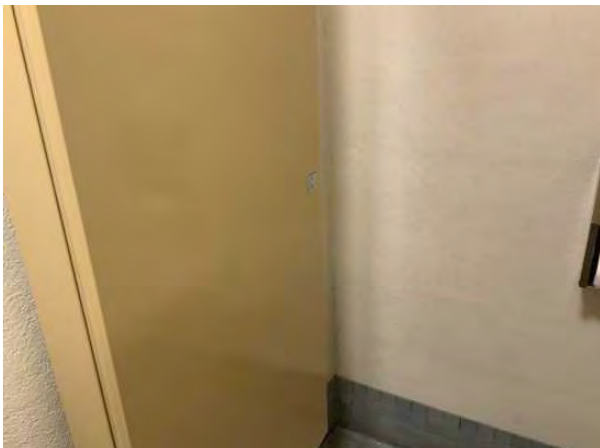
Photos for Barrier ID: AX298700

Assembly	Restroom
Type	Restroom/Bathroom-Water Closet
ADA Standard	CBC Chap 11B-404, 604.8.1.2
Barrier Detail	CALIFORNIA: The toilet stall door is not compliant.
Location Description	Men's Restroom
Observed	Oct 16, 2022 by Justin.vang@bureauveritas.com
Site Conditions	The stall door width is 24-1/2".

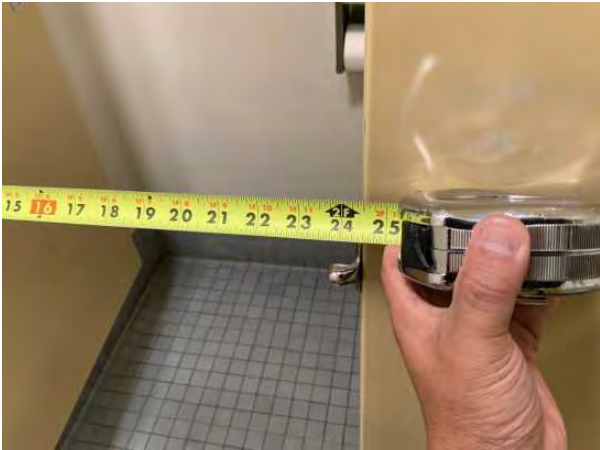
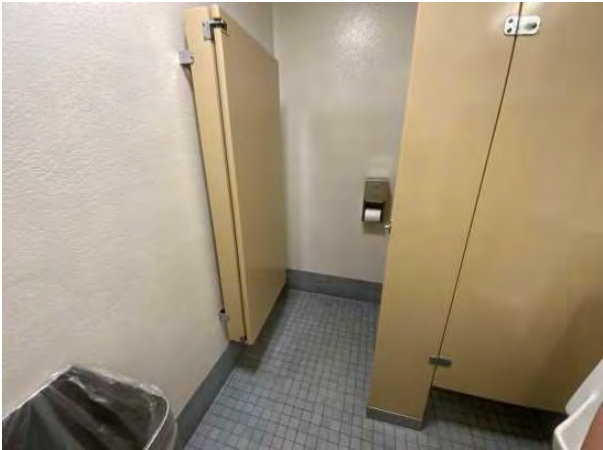
Photos for Barrier ID: AX298701

Assembly	Restroom
Type	Restroom/Bathroom - Water Closet
ADA Standard	CBC Chap 11B-604.8.1.1

Location Description	Men's Restroom
Observed	Oct 16, 2022 by Justin.vang@bureauveritas.com
Site Conditions	The stall dimension is 36" x 63".

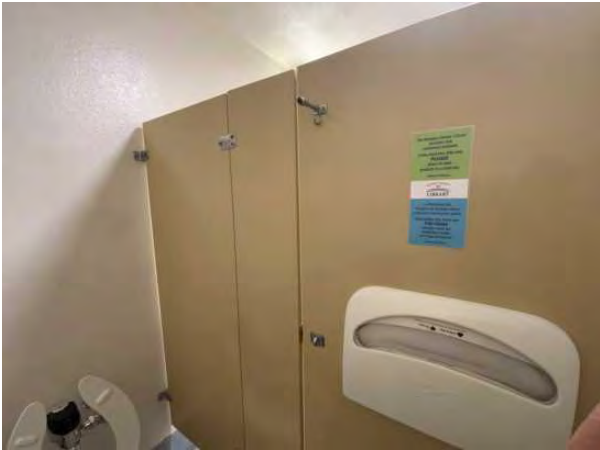
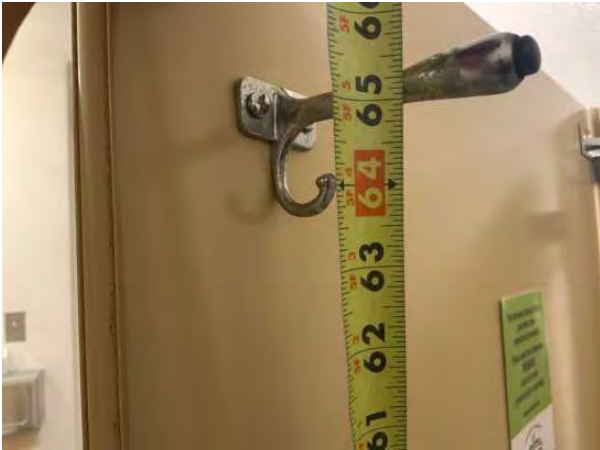
Assembly	Restroom
Type	Restroom/Bathroom - Coat Hook
ADA Standard	308
Barrier Detail	The coat hook is not within an allowable reach range.
Location Description	Men's Restroom
Observed	Oct 16, 2022 by Justin.vang@bureauveritas.com
Site Conditions	The coat hook is 64" high.

Install the coat hook within an allowable reach range. Unobstructed Forward Reach: Where a forward reach is unobstructed, the high forward reach shall be 48" maximum and the low forward reach shall be 15" minimum above the finish floor or ground. Obstructed High Forward Reach: Where a high forward reach is over an obstruction, the clear floor space shall extend beneath the element for a distance not less than the required reach depth over the obstruction. The high forward reach shall be 48" maximum where the reach depth is 20" maximum. Where the reach depth exceeds 20", the high forward reach shall be 44" maximum and the reach depth shall be 25" maximum. Unobstructed Side Reach: Where a clear floor or ground space allows a parallel approach to an element and the side reach is unobstructed, the high side reach shall be 48" maximum and the low side reach shall be 15" minimum above the finish floor or ground. [EXCEPTION: An obstruction shall be permitted between the clear floor or ground space and the element where the depth of the obstruction is 10" maximum.] Obstructed High Side Reach: Where a clear floor or ground space allows a parallel approach to an element and the high side reach is over an obstruction, the height of the obstruction shall be 34" maximum and the depth of the obstruction shall be 24" maximum. The high side reach shall be 48" maximum for a reach depth of 10" maximum. Where the reach depth exceeds 10", the high side reach shall be 46" maximum for a reach depth of 24" maximum. [ADVISORY for Children's Forward or Side Reach Ranges: High reach (maximum): 36" for ages 3 to 4; 40" for ages 5 to 8; and 44" for ages 9 to 12. Low reach (minimum): 20" for ages 3 to 4; 18" for ages 5 to 8; and 16" for ages 9 to 12.]

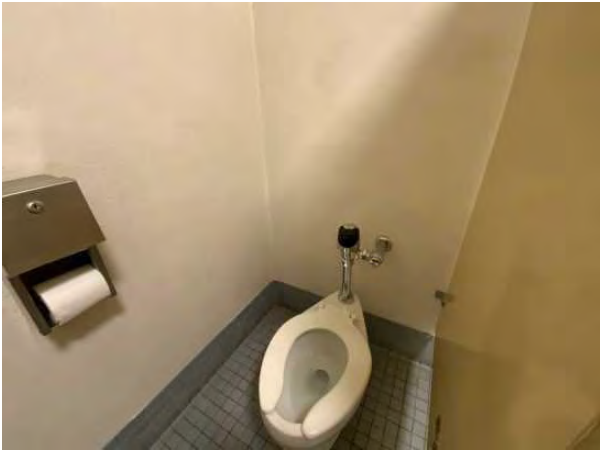
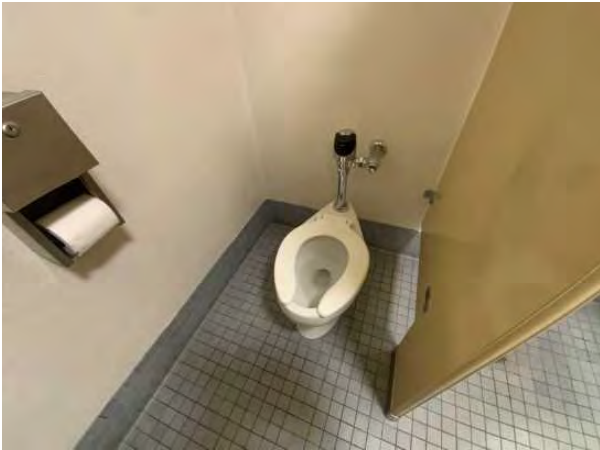
Assembly	Restroom
Type	Restroom/Bathroom - Water Closet
ADA Standard	604.5.2
Barrier Detail	The grab bars at the water closet are not compliant.
Location Description	Men's Restroom
Observed	Oct 16, 2022 by Justin.vang@bureauveritas.com
Site Conditions	A rear grab bar and side grab bar is not provided.

Install compliant grab bars. Grab bars shall be installed in a horizontal position at height of 33" minimum to 36" maximum above the finish floor, measured to the top of the gripping surface. The rear wall grab bar shall be 36" long minimum and extend from the centerline of the water closet 12" minimum on one side and 24" minimum on the other side. [EXCEPTIONS: 1. The rear grab bar shall be permitted to be 24" long minimum, centered on the water closet, where wall space does not permit a length of 36" minimum due to the location of a recessed fixture adjacent to the water closet. 2. Where an administrative authority requires flush controls for flush valves to be located in a position that conflicts with the location of the rear grab bar, then the rear grab bar shall be permitted to be split or shifted to the open side of the toilet area.] The side wall grab bar shall be 42" long minimum, located 12" maximum from the rear wall and extending 54" minimum. A continuous grab bar is allowable in lieu of rear and side grab bars. [ADVISORY: It is advisable, but not required, to use the specifications for children where children are the primary users of the restroom. Guidance in applying the specifications for children according to the age group served reflects the differences in the size, stature, and reach ranges of children ages 3 to 12. The specifications chosen should correspond to the age of the primary user group. The specifications of one age group should be applied consistently in the installation of a water closet and related elements. Water Closet Centerline: Ages 3 and 4- 12"; Ages 5 through 8- 12" to 15"; Ages 9 through 12- 15" to 18". Toilet Seat Height: Ages 3 and 4- 11" to 12"; Ages 5 through 8- 12" to 15"; Ages 9 through 12- 15" to 17". Grab Bar Height: Ages 3 and 4- 18" to 20"; Ages 5 through 8- 20" to 25"; Ages 9 through 12- 25" to 27"; Dispenser Height: Ages 3 and 4- 14"; Ages 5 through 8- 14" to 17"; Ages 9 through 12- 17" to 19"].
