Sonoma County Library Annex Building Study

FINAL REPORT | 19 APRIL 2023

FACILITY CONDITION ASSESSMENT

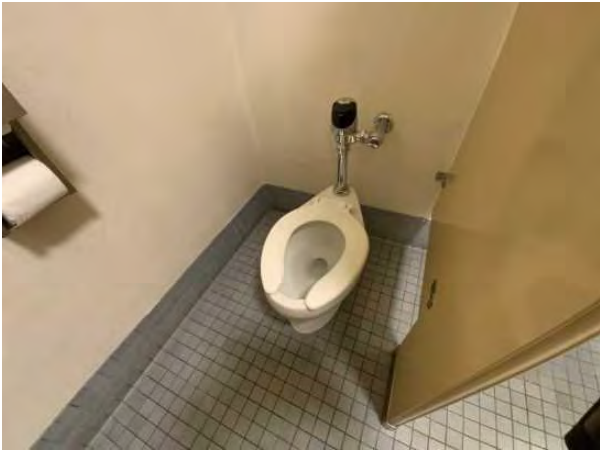
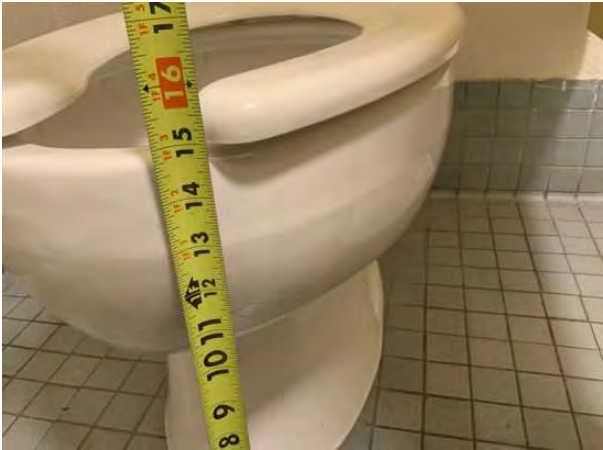
Assembly	Restroom
Type	Restroom/Bathroom - Water Closet
ADA Standard	604.4

Location Description	Men's Restroom
Observed	Oct 16, 2022 by Justin.vang@bureauveritas.com
Site Conditions	The seat height is 15-3/4".

Remove and replace with a toilet that has a compliant seat height. The seat height of a water closet shall be 17" minimum and 19" maximum above the finish floor, measured to the top of the seat. Seats shall not be sprung to return to a lifted position. [EXCEPTIONS: 1. A water closet in a toilet room for a single occupant accessed only through a private office and not for common use or public use shall not be required to comply. 2. In residential dwelling units, the height of water closets shall be permitted to be 15" minimum and 19" maximum above the finish floor measured to the top of the seat.] [ADVISORY: It is advisable, but not required, to use the specifications for children where children are the primary users of the restroom. Guidance in applying the specifications for children according to the age group served reflects the differences in the size, stature, and reach ranges of children ages 3 to 12. The specifications chosen should correspond to the age of the primary user group. The specifications of one age group should be applied consistently in the installation of a water closet and related elements. Water Closet Centerline: Ages 3 and 4- 12"; Ages 5 through 8- 12" to 15"; Ages 9 through 12- 15" to 18". Toilet Seat Height: Ages 3 and 4- 11" to 12"; Ages 5 through 8- 12" to 15"; Ages 9 through 12- 15" to 17". Grab Bar Height: Ages 3 and 4- 18" to 20"; Ages 5 through 8- 20" to 25"; Ages 9 through 12- 25" to 27"; Dispenser Height: Ages 3 and 4- 14"; Ages 5 through 8- 14" to 17"; Ages 9 through 12- 17" to 19"].

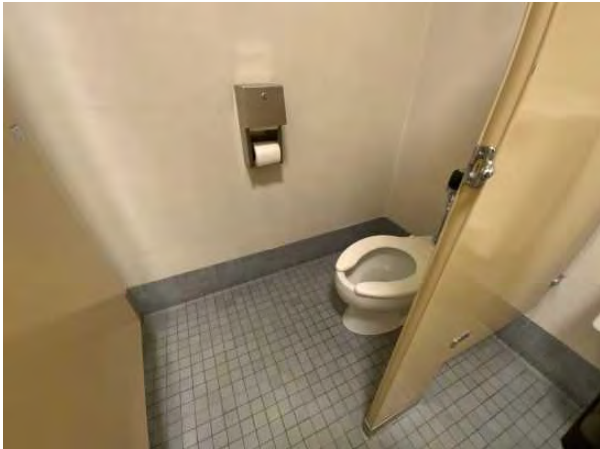
Assembly	Restroom
Type	Restroom/Bathroom - Door
ADA Standard	404.2.9
Barrier Detail	
The force required to open the interior, hinged, non-fire door is more than 5 pounds.	
Location Description	Women's Restroom
Observed	Oct 16, 2022 by Justin.vang@bureauveritas.com
Site Conditions	The door require to open the door is 19 pounds.

Adjust closer or replace with an closer that requires no more 5 pounds of force to stop the door motion. This barrier must be removed in conjunction with barrier ID 298675. The maximum force for pushing or pulling open a door shall be for interior hinged doors: 5 lbs (22.2N). The force for pushing or pulling open a door or gate other than fire doors shall be as follows: 1. Interior hinged doors and gates: 5 pounds (22.2 N) maximum. 2. Sliding or folding doors: 5 pounds (22.2 N) maximum. These forces do not apply to the force required to retract latch bolts or disengage other devices that hold the door or gate in a closed position. Note: Fire doors shall have a minimum opening force allowable by the appropriate administrative authority.

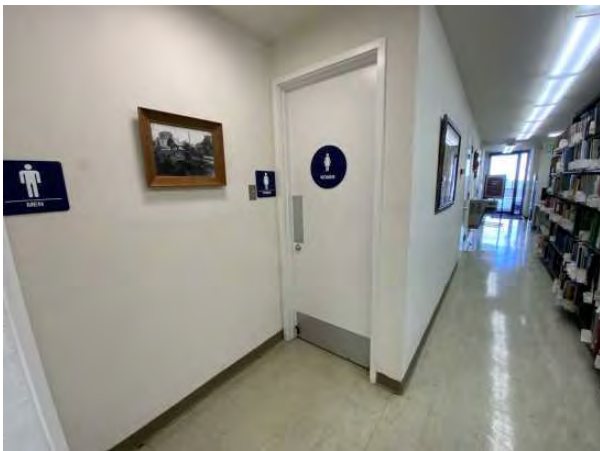
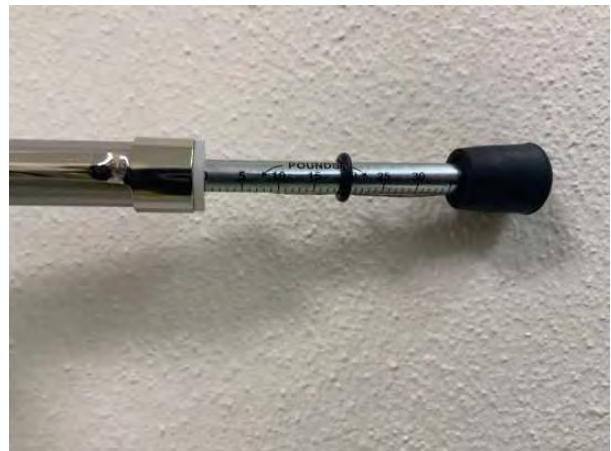
Photos for Barrier ID: AX298674

Assembly	Restroom
Type	Restroom/Bathroom - Door
ADA Standard	404.2.8

Adjust closer or remove and replace closer to ensure that the door has a closure time of at least 5 seconds within 12 degrees of the latch. This barrier must be removed in conjunction with barrier ID 298674. The cost of this barrier removal is covered under barrier ID 298674 and therefore, the cost is shown as \$0. Door closers and gate closers shall be adjusted so that from an open position of 90 degrees, the time required to move the door to a position of 12 degrees from the latch is 5 seconds minimum.

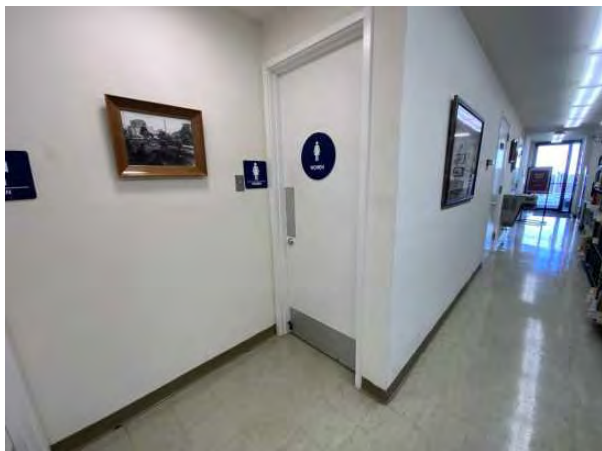
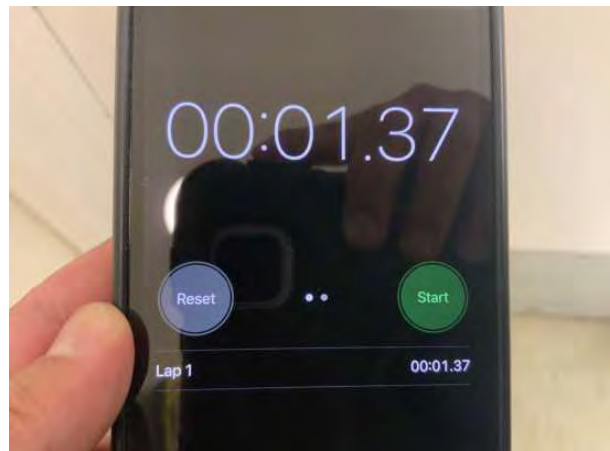
Photos for Barrier ID: AX298675

Assembly	Restroom
Type	Restroom/Bathroom - Door
ADA Standard	404.2.10

Site Conditions A door stop is provided within the required 10" to be smooth.

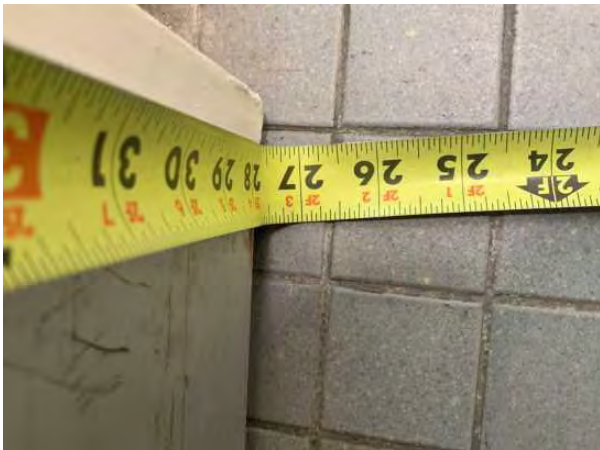
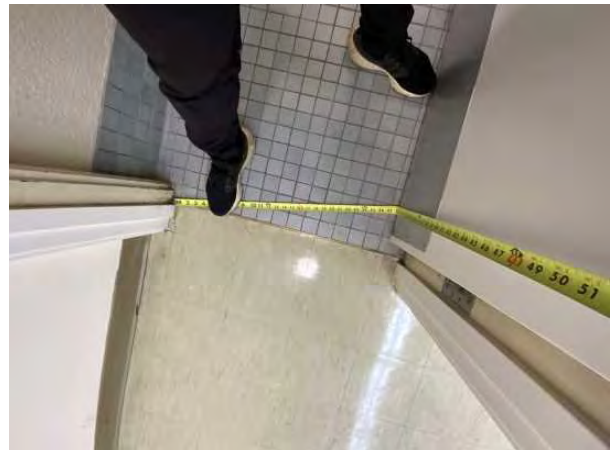
Photos for Barrier ID: AX298677

Assembly	Restroom
Type	Restroom/Bathroom - Door
ADA Standard	404.2; Table 404.2.4.1

Location Description	Women's Restroom
Observed	Oct 16, 2022 by Justin.vang@bureauveritas.com
Site Conditions	The maneuvering clearance parallel to the door is 3".

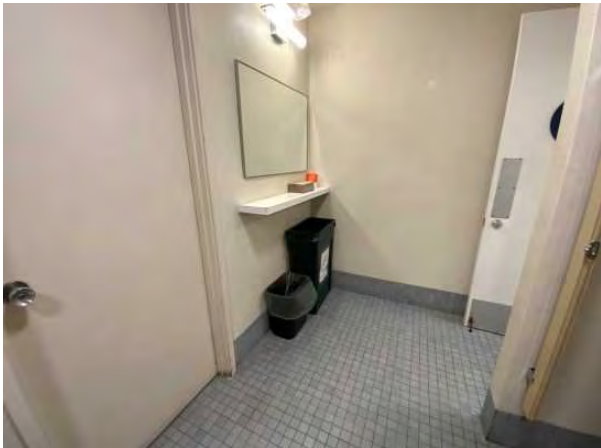
Photos for Barrier ID: AX298680

Assembly	Restroom
Type	Restroom/Bathroom - Floor Space
ADA Standard	304, 603.2.1; 603.2.2
Barrier Detail	The required turning space within the restroom is not provided.
Location Description	Women's Restroom
Observed	Oct 16, 2022 by Justin.vang@bureauveritas.com
Site Conditions	The turning space is 54-1/4" wide.

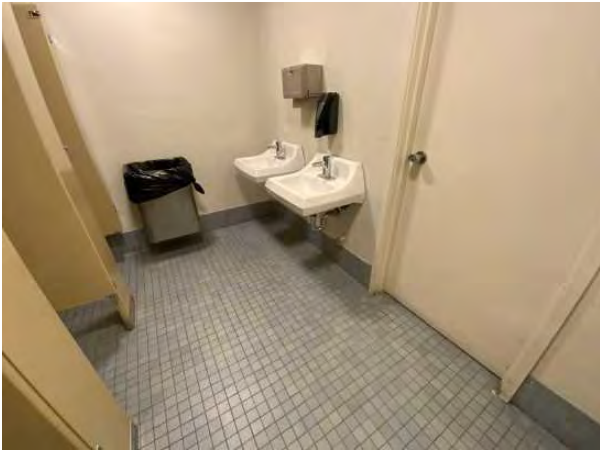
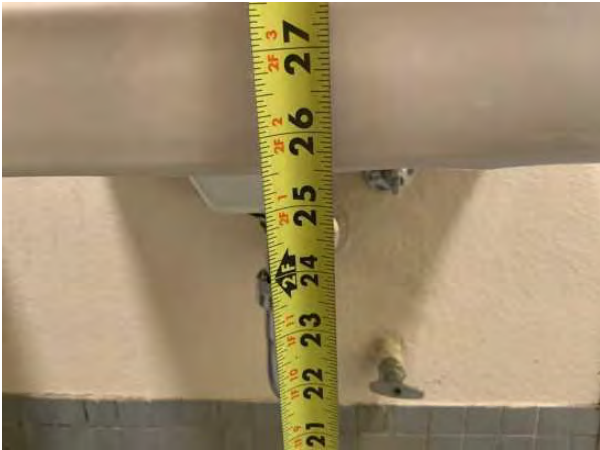
Assembly	Restroom
Type	Restroom/Bathroom - Lavatory
ADA Standard	606.5
Barrier Detail	Pipes are not insulated.
Location Description	Women's Restroom
Observed	Oct 16, 2022 by Justin.vang@bureauveritas.com
Site Conditions	Lavatory drain pipes are not insulated.

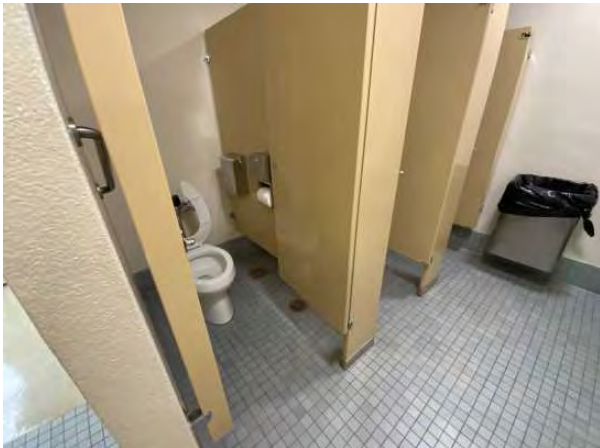
Photos for Barrier ID: AX298710

Assembly	Restroom
Type	Restroom/Bathroom-Water Closet
ADA Standard	CBC Chap 11B-404, 604.8.1.2
Barrier Detail	CALIFORNIA: The toilet stall door is not compliant.
Location Description	Women's Restroom
Observed	Oct 16, 2022 by Justin.vang@bureauveritas.com
Site Conditions	The stall door width is 22".

Provide a compliant toilet stall door. Toilet compartment doors, including door hardware, shall have the required maneuvering clearance. If the approach is from the push side of the compartment door, clearance between the door side of the compartment and any obstruction shall be 48 inches minimum measured perpendicular to the compartment door in its closed position. Doors shall be located in the front partition or in the side wall or partition farthest from the water closet. Where located in the front partition, the door opening shall be 4 inches maximum from the side wall or partition farthest from the water closet. Where located in the side wall or partition, the door opening shall be farthest from the water closet and shall be 54 inches minimum from the rear wall. The door shall be self-closing. A door pull shall be placed on both sides of the door near the latch. Operable parts of latches and pull hardware shall be 34 inches minimum and 44 inches maximum above the finish floor or ground. Doors shall not swing into the clear floor space or clearance required for any fixture. Doors may swing into that portion of maneuvering space which does not overlap the clearance required at a water closet. Swinging door and gate surfaces within 10 inches of the finish floor or ground measured vertically shall have a smooth surface on the push side extending the full width of the door or gate. Parts creating horizontal or vertical joints in these surfaces shall be within 1/16 inch of the same plane as the other and be free of sharp or abrasive edges. Cavities created by added kick plates shall be capped. [Exception: Doors that do not extend to within 10 inches of the finish floor or ground shall not be required to comply] The force for pushing or pulling open the door shall be 5 pounds (22.2 N) maximum. Clear width. Door openings shall provide a clear width of 32 inches minimum. Clear openings of doorways with swinging doors shall be measured between the face of the door and the stop, with the door open 90 degrees. Openings more than 24 inches deep shall provide a clear opening of 36 inches minimum. There shall be no projections into the required clear opening width lower than 34 inches above the finish floor or ground. Projections into the clear opening width between 34 inches and 80 inches above the finish floor or ground shall not exceed 4 inches. [Exceptions: 1. In alterations, a projection of 5/8 inch (15.9 mm) maximum into the required clear width shall be permitted for the latch side stop. 2. Door closers and door stops shall be permitted to be 78 inches minimum above the finish floor or ground.].

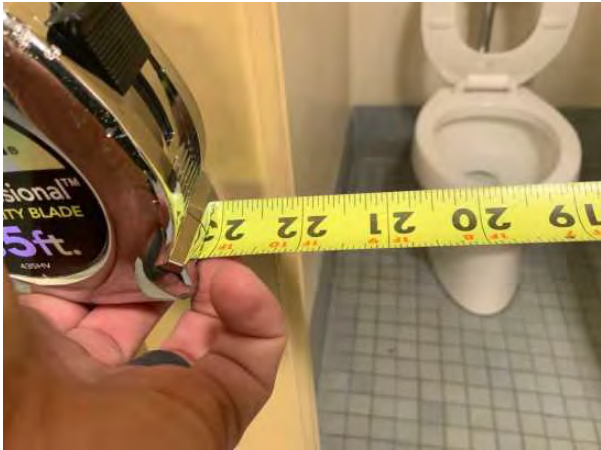
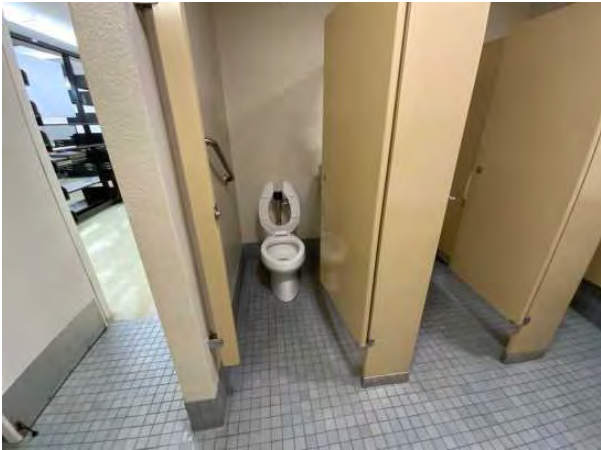
Assembly	Restroom
Type	Restroom/Bathroom - Water Closet
ADA Standard	CBC Chap 11B-604.8.1.1

Location Description	Women's Restroom
Observed	Oct 16, 2022 by Justin.vang@bureauveritas.com
Site Conditions	The stall dimension is 34" x 56".

Provide a wheelchair stall of compliant dimensions for an in-swinging door: minimum 60" width and minimum 92" depth for a wall hung closet and minimum 95" depth for a floor mounted water closet. For an in-swinging compartment door, additional maneuvering clearance minimum 60" wide by minimum 36" deep must be provided outside of the required clearance around the water closet of 60" minimum wide by 56" or 59" minimum deep. Clearance at the water closet shall be minimum 59" depth from the rear wall for a floor mounted water closet and minimum 56" depth for a wall hung water closet. The 60" minimum wide by 36" minimum deep maneuvering clearance overlaps the required 60" minimum wide by 48" minimum deep clearance required at the front of all water closets.

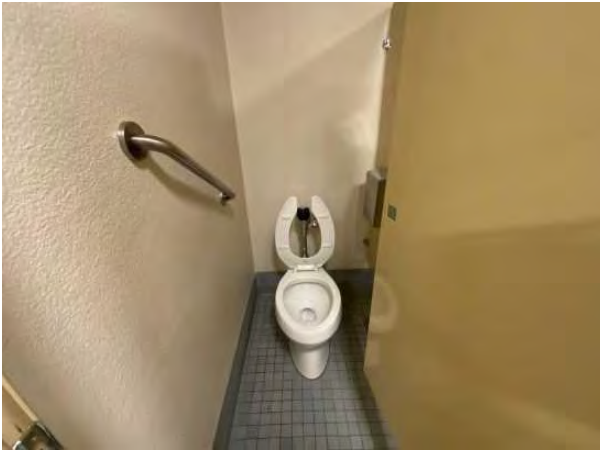
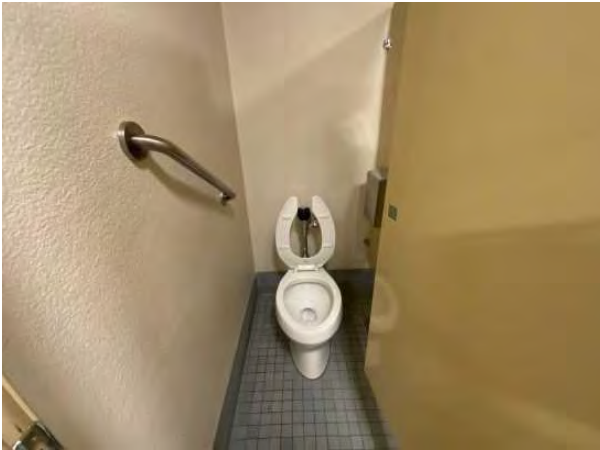
Assembly	Restroom
Type	Restroom/Bathroom - Water Closet
ADA Standard	604.5.1
Barrier Detail	The side grab bar at the water closet is not compliant.
Location Description	Women's Restroom
Observed	Oct 16, 2022 by Justin.vang@bureauveritas.com
Site Conditions	The side grab bar is in a diagonal position.

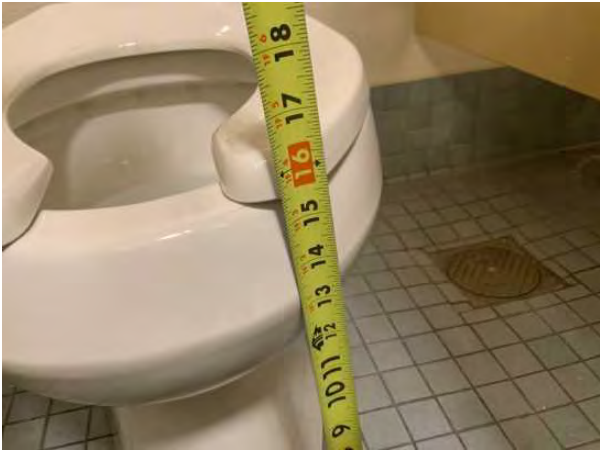
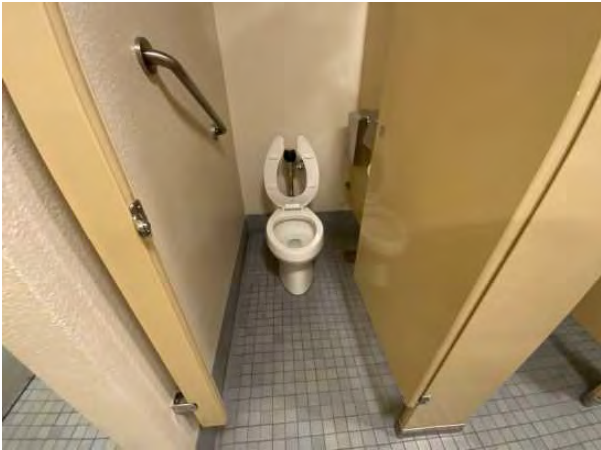
Assembly	Restroom
Type	Restroom/Bathroom - Water Closet
ADA Standard	604.4

Location Description	Women's Restroom
Observed	Oct 16, 2022 by Justin.vang@bureauveritas.com
Site Conditions	The seat height is 16-1/2".

Remove and replace with a toilet that has a compliant seat height. The seat height of a water closet shall be 17" minimum and 19" maximum above the finish floor, measured to the top of the seat. Seats shall not be sprung to return to a lifted position. [EXCEPTIONS: 1. A water closet in a toilet room for a single occupant accessed only through a private office and not for common use or public use shall not be required to comply. 2. In residential dwelling units, the height of water closets shall be permitted to be 15" minimum and 19" maximum above the finish floor measured to the top of the seat.] [ADVISORY: It is advisable, but not required, to use the specifications for children where children are the primary users of the restroom. Guidance in applying the specifications for children according to the age group served reflects the differences in the size, stature, and reach ranges of children ages 3 to 12. The specifications chosen should correspond to the age of the primary user group. The specifications of one age group should be applied consistently in the installation of a water closet and related elements. Water Closet Centerline: Ages 3 and 4- 12"; Ages 5 through 8- 12" to 15"; Ages 9 through 12- 15" to 18". Toilet Seat Height: Ages 3 and 4- 11" to 12"; Ages 5 through 8- 12" to 15"; Ages 9 through 12- 15" to 17". Grab Bar Height: Ages 3 and 4- 18" to 20"; Ages 5 through 8- 20" to 25"; Ages 9 through 12- 25" to 27"; Dispenser Height: Ages 3 and 4- 14"; Ages 5 through 8- 14" to 17"; Ages 9 through 12- 17" to 19"].

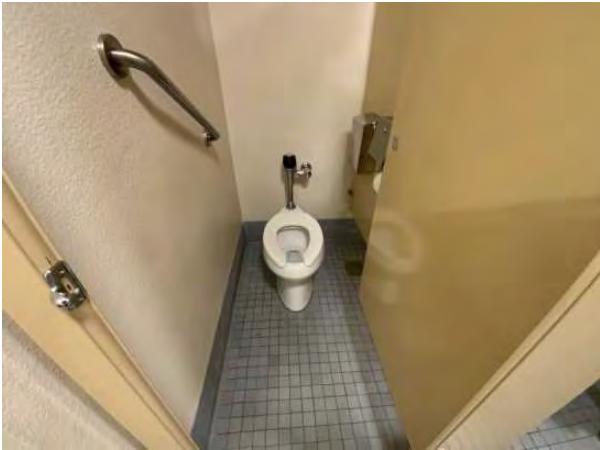
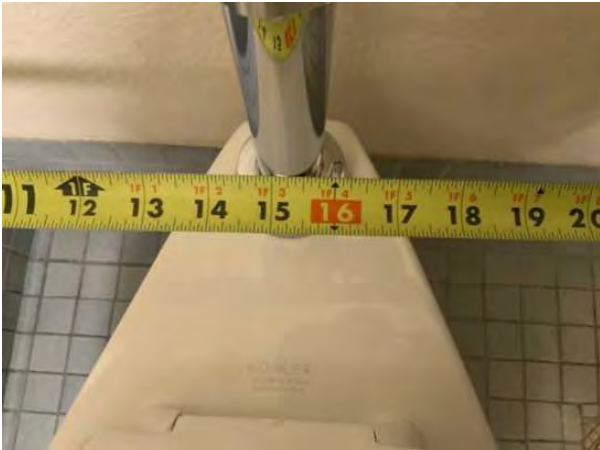
Assembly	Restroom
Type	Restroom/Bathroom - Water Closet
ADA Standard	CBC Chap 11B-604.3

Location Description	Women's Restroom
Observed	Oct 16, 2022 by Justin.vang@bureauveritas.com
Site Conditions	The water closet centerline is 15-1/4" from the side wall.

Provide a water closet with centerline 17" minimum to 18" maximum from the side wall or partition. The water closet shall be positioned with a wall or partition to the rear and to one side. The centerline of the water closet shall be 17" minimum to 18" maximum from the side wall or partition in a wheelchair stall. Water closets shall be arranged for a left-hand or right-hand approach. [ADVISORY: It is advisable, but not required, to use the specifications for children where children are the primary users of the restroom. Guidance in applying the specifications for children according to the age group served reflects the differences in the size, stature, and reach ranges of children ages 3 to 12. The specifications chosen should correspond to the age of the primary user group. The specifications of one age group should be applied consistently in the installation of a water closet and related elements. Water Closet Centerline: Ages 3 and 4- 12"; Ages 5 through 8- 12" to 15"; Ages 9 through 12- 15" to 18". Toilet Seat Height: Ages 3 and 4- 11" to 12"; Ages 5 through 8- 12" to 15"; Ages 9 through 12- 15" to 17". Grab Bar Height: Ages 3 and 4- 18" to 20"; Ages 5 through 8- 20" to 25"; Ages 9 through 12- 25" to 27"; Dispenser Height: Ages 3 and 4- 14"; Ages 5 through 8- 14" to 17"; Ages 9 through 12- 17" to 19"].

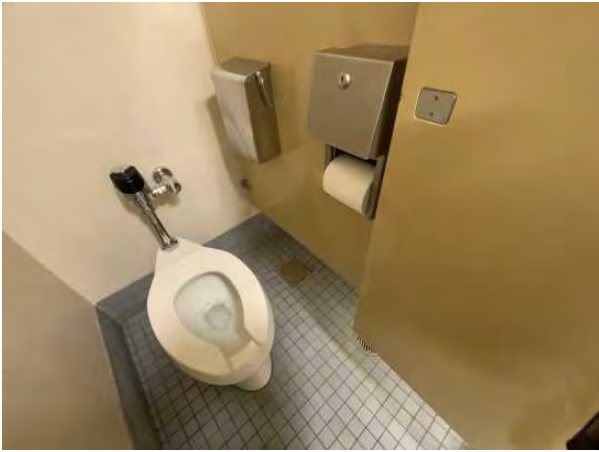
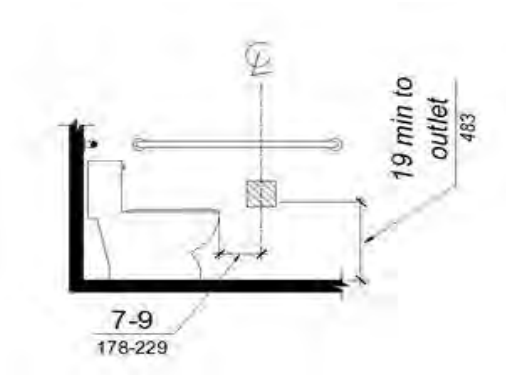
Assembly	Restroom
Type	Restroom/Bathroom - Water Closet
ADA Standard	CBC Chap 11B-604.7, 604.9, 609.3
Barrier Detail	CALIFORNIA: The toilet paper dispenser is not compliant.
Location Description	Women's Restroom
Observed	Oct 16, 2022 by Justin.vang@bureauveritas.com
Site Conditions	The paper towel dispenser is directly adjacent to the toilet.

Remove and relocate the toilet paper dispenser. Toilet paper dispensers shall be 7" minimum and 9" maximum in front of the water closet, measured to the centerline of the dispenser. The outlet of the dispenser shall be below the grab bar and 19" minimum above the finish floor. The toilet paper dispenser shall not be located behind grab bars. The top of projecting toilet paper dispensers shall be located 1-1/2" minimum below the grab bar. Dispensers shall not be of a type that controls delivery or that does not allow continuous paper flow. [ADVISORY: It is advisable, but not required, to use the specifications for children where children are the primary users of the restroom. Guidance in applying the specifications for children according to the age group served reflects the differences in the size, stature, and reach ranges of children ages 3 to 12. The specifications chosen should correspond to the age of the primary user group. The specifications of one age group should be applied consistently in the installation of a water closet and related elements. Water Closet Centerline: Ages 3 and 4- 12"; Ages 5 through 8- 12" to 15"; Ages 9 through 12- 15" to 18". Toilet Seat Height: Ages 3 and 4- 11" to 12"; Ages 5 through 8- 12" to 15"; Ages 9 through 12- 15" to 17". Grab Bar Height: Ages 3 and 4- 18" to 20"; Ages 5 through 8- 20" to 25"; Ages 9 through 12- 25" to 27"; Dispenser Height: Ages 3 and 4- 14"; Ages 5 through 8- 14" to 17"; Ages 9 through 12- 17" to 19"].

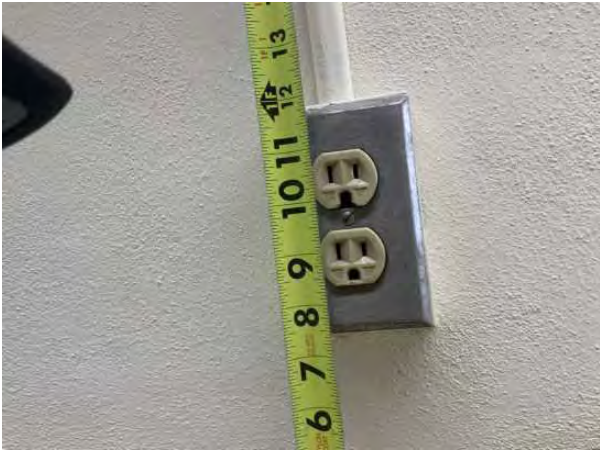
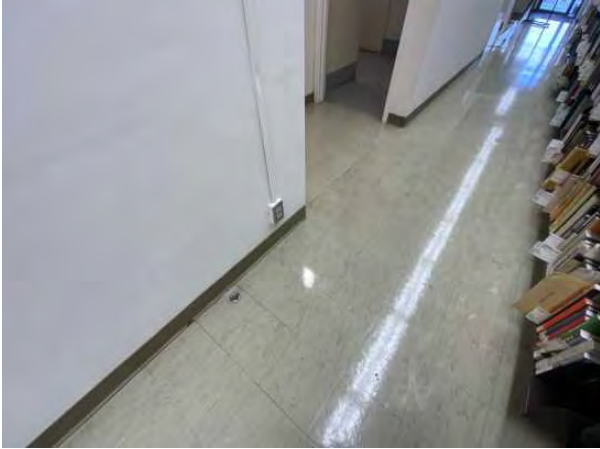
Assembly	Accessible Route
Type	Controls And Dispensers
ADA Standard	CBC Chap 11B-308.1
Barrier Detail	CALIFORNIA: The location of electrical outlets are not compliant.
Location Description	Electrical Outlets throughout Building
Observed	Oct 16, 2022 by Justin.vang@bureauveritas.com

Relocate the electrical outlet to a compliant location. Electrical switches: Controls and switches intended to be used by the occupant of a room or area to control lighting and receptacle outlets, appliances or cooling, heating and ventilating equipment, shall comply with reach range requirements except the low reach shall be measured to the bottom of the outlet box and the high reach shall be measured to the top of the outlet box. Electrical receptacle outlets: Electrical receptacle outlets on branch circuits of 30 amperes or less and communication system receptacles shall comply with reach range requirements except the low reach shall be measured to the bottom of the outlet box and the high reach shall be measured to the top of the outlet box. Unobstructed Forward Reach; Where a forward reach is unobstructed, the high forward reach shall be 48 inches maximum and the low forward reach shall be 15 inches minimum above the finish floor or ground. Obstructed High Forward Reach: Where a high forward reach is over an obstruction, the clear floor space shall extend beneath the element for a distance not less than the required reach depth over the obstruction. The high forward reach shall be 48 inches maximum where the reach depth is 20 inches maximum. Where the reach depth exceeds 20 inches, the high forward reach shall be 44 inches maximum and the reach depth shall be 25 inches maximum. Unobstructed Side Reach: Where a clear floor or ground space allows a parallel approach to an element and the side reach is unobstructed, the high side reach shall be 48 inches maximum and the low side reach shall be 15 inches minimum above the finish floor or ground. [EXCEPTIONS: 1. An obstruction shall be permitted between the clear floor or ground space and the element where the depth of the obstruction is 10 inches maximum. 2. Operable parts of fuel dispensers shall be permitted to be 54 inches maximum measured from the surface of the vehicular way where fuel dispensers are installed on existing curbs.] Obstructed High Side Reach: Where a clear floor or ground space allows a parallel approach to an element and the high side reach is over an obstruction, the height of the obstruction shall be 34 inches maximum and the depth of the obstruction shall be 24 inches maximum. The high side reach shall be 48 inches maximum for a reach depth of 10 inches maximum. Where the reach depth exceeds 10 inches, the high side reach shall be 46 inches maximum for a reach depth of 24 inches maximum. [EXCEPTIONS: 1. The top of washing machines and clothes dryers shall be permitted to be 36 inches maximum above the finish floor. 2. Operable parts of fuel dispensers shall be permitted to be 54 inches maximum measured from the surface of the vehicular way where fuel dispensers are installed on existing curbs.]

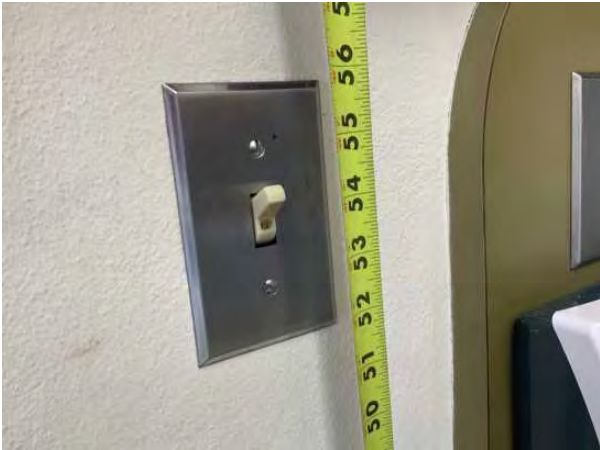
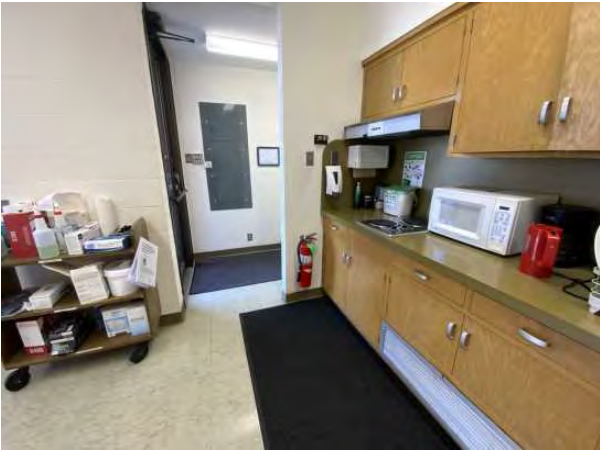
Assembly	Accessible Route
Type	Controls And Dispensers
ADA Standard	CBC Chap 11B-308.1
Barrier Detail	CALIFORNIA: The location of electrical controls are not compliant.
Location Description	Electrical Switches throughout Building
Observed	Oct 16, 2022 by Justin.vang@bureauveritas.com

Relocate the electrical control to a compliant location. Electrical switches: Controls and switches intended to be used by the occupant of a room or area to control lighting and receptacle outlets, appliances or cooling, heating and ventilating equipment, shall comply with reach range requirements except the low reach shall be measured to the bottom of the outlet box and the high reach shall be measured to the top of the outlet box. Electrical receptacle outlets: Electrical receptacle outlets on branch circuits of 30 amperes or less and communication system receptacles shall comply with reach range requirements except the low reach shall be measured to the bottom of the outlet box and the high reach shall be measured to the top of the outlet box. Unobstructed Forward Reach; Where a forward reach is unobstructed, the high forward reach shall be 48 inches maximum and the low forward reach shall be 15 inches minimum above the finish floor or ground. Obstructed High Forward Reach: Where a high forward reach is over an obstruction, the clear floor space shall extend beneath the element for a distance not less than the required reach depth over the obstruction. The high forward reach shall be 48 inches maximum where the reach depth is 20 inches maximum. Where the reach depth exceeds 20 inches, the high forward reach shall be 44 inches maximum and the reach depth shall be 25 inches maximum. Unobstructed Side Reach: Where a clear floor or ground space allows a parallel approach to an element and the side reach is unobstructed, the high side reach shall be 48 inches maximum and the low side reach shall be 15 inches minimum above the finish floor or ground. [EXCEPTIONS: 1. An obstruction shall be permitted between the clear floor or ground space and the element where the depth of the obstruction is 10 inches maximum. 2. Operable parts of fuel dispensers shall be permitted to be 54 inches maximum measured from the surface of the vehicular way where fuel dispensers are installed on existing curbs.] Obstructed High Side Reach: Where a clear floor or ground space allows a parallel approach to an element and the high side reach is over an obstruction, the height of the obstruction shall be 34 inches maximum and the depth of the obstruction shall be 24 inches maximum. The high side reach shall be 48 inches maximum for a reach depth of 10 inches maximum. Where the reach depth exceeds 10 inches, the high side reach shall be 46 inches maximum for a reach depth of 24 inches maximum. [EXCEPTIONS: 1. The top of washing machines and clothes dryers shall be permitted to be 36 inches maximum above the finish floor. 2. Operable parts of fuel dispensers shall be permitted to be 54 inches maximum measured from the surface of the vehicular way where fuel dispensers are installed on existing curbs.]
